**FINAL REPORT**

# **Caledon Road Improvements EA – Geomorphic Assessment**

Date: May 2014

**Project name:** Caledon Road Improvements EA

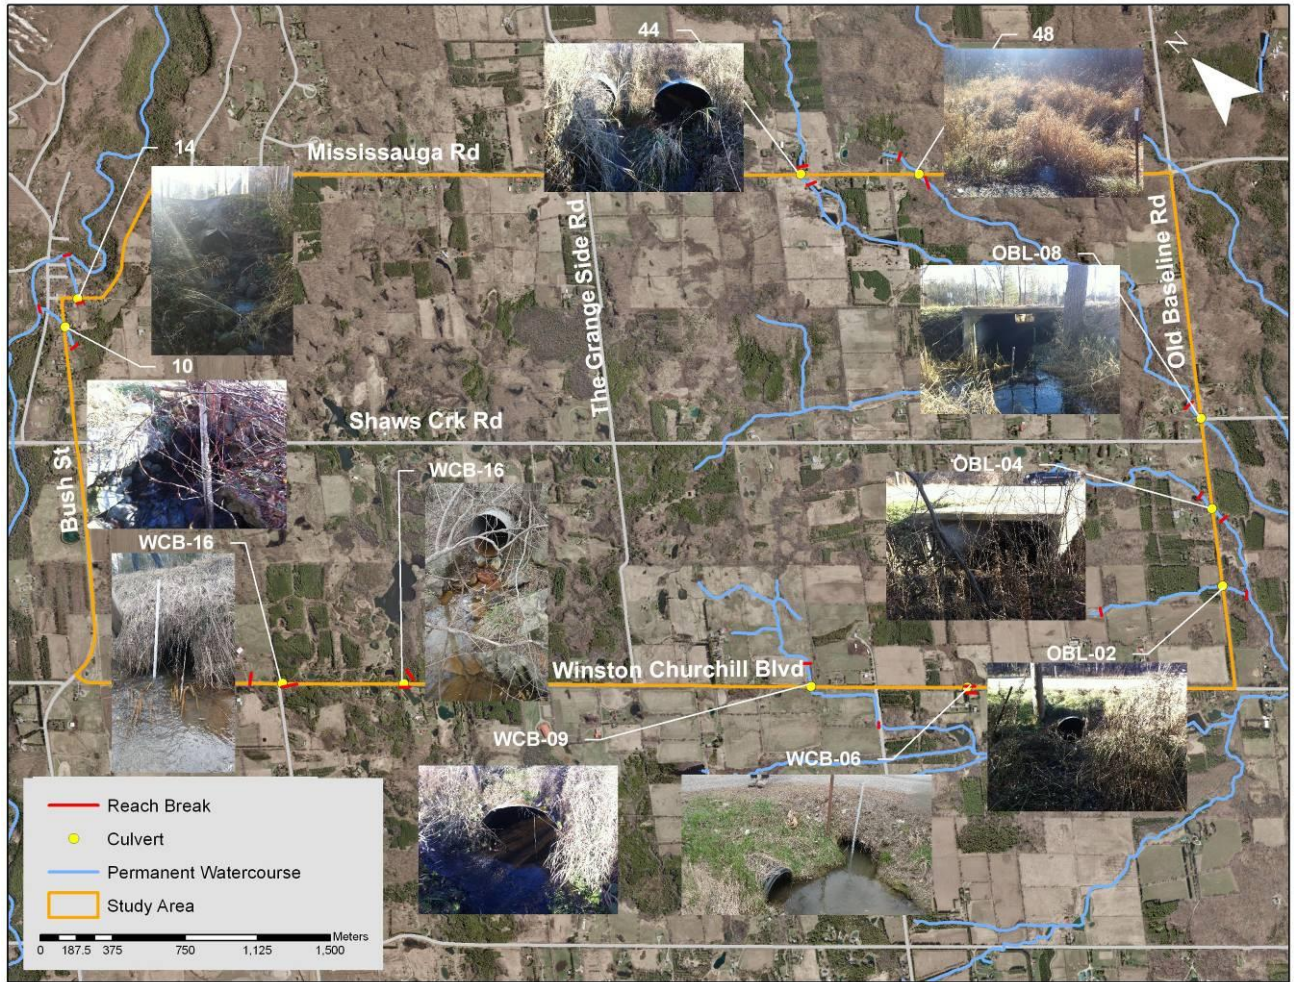
**Figure 5.1:** Culvert structures photographed at each crossing location.

Crossing	Structure		Bankfull Dimensions (m)		Relative Crossing Size			Gradient	Valley Setting	Flow Restriction
	Type	Opening Width (m)	Width	Depth	Channel Width < Opening	Channel Width = Opening	Channel Width > Opening			
OBL-02	CSP	0.6	~1.25	~0.23			√	low	Partially confined	Woody debris
OBL-04	Concrete Box	3.25	~3.5	~0.3			√	low	Partially confined	Woody debris
OBL-08	Concrete Box	4.5	~4.5	~0.5		√		low	Partially confined	vegetation
44	Double CSP	0.75	~2.0	~0.6			√	low	unconfined	vegetation
48	CSP	0.5	n/a	n/a				low	unconfined	vegetation
10	Plastic Pipe	0.45	~2.75	~0.3			√	moderate	unconfined	Concrete debris
14	CSP	0.6	~1.1	~0.3			√	high	unconfined	none
WCB-06	CSP	0.6	~0.8	~0.36			√	low	unconfined	vegetation
WCB-09	CSP	1.34	~1.9	~0.35			√	high	Partially confined	vegetation
WCB-14	CSP	0.45	~0.63	~0.12			√	low	Partially confined	none
WCB-16	CSP	0.9	~0.76	~0.41		√		high	Partially Confined	Bank failure

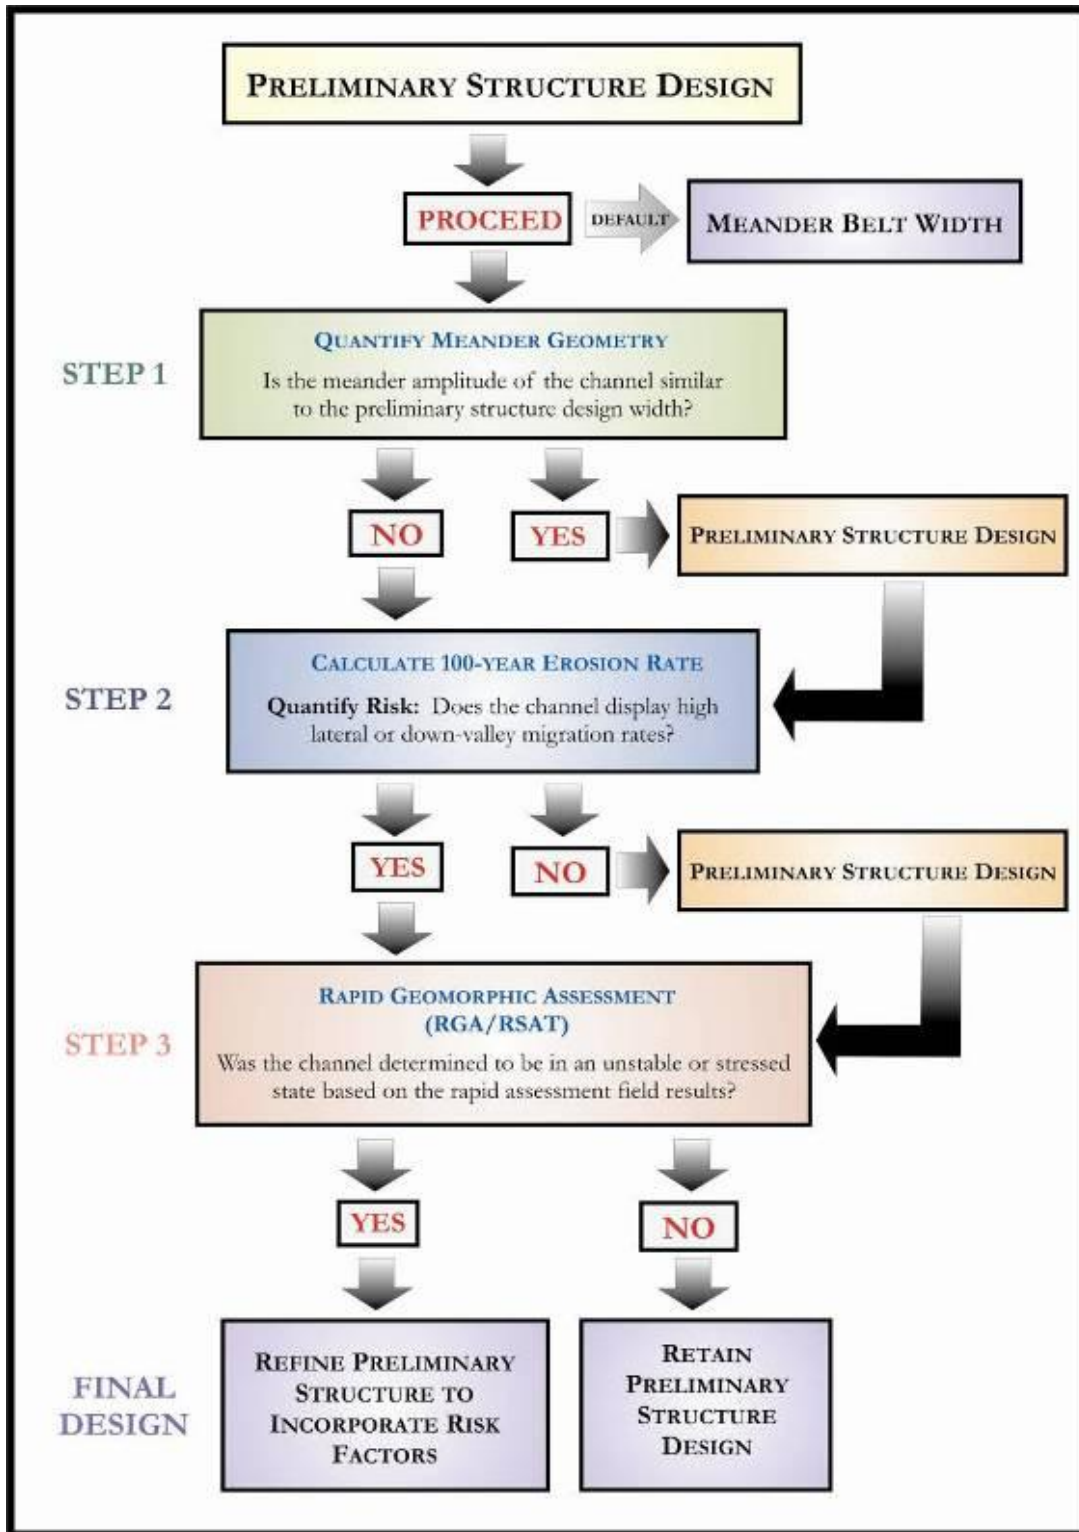
**Figure 7.1:** Geomorphic risk assessment protocol for span recommendations (PARISH Geomorphic Ltd, 2006).

Culvert	Channel Conditions / Modifications	Meander Amplitude (distance u/s or d/s) (m)	Bankfull Width (m) [at crossing]	Valley Setting	Preliminary Meander Belt Width (m)	Preliminary MBW Range (m)	RGA score	Existing Structure (mm)	Recommended Structure Size (m)
OBL-02	Farm upstream	n/a	1.80	Partially Confined	11.62	8.31 – 13.63	0.26	600	3.00
OBL-04	Offline Pond U/S	n/a	3.26	Partially Confined	22.25	16.15 – 25.37	0.31	3300 x 1200	6.00
OBL-08	Online Pond U/S	n/a	3.00	Partially Confined	19.14	14.72 – 23.68	0.24	3050 x 1400	6.00
WCB-06	Ditch, another CSP located 20m D/S of outlet	n/a	0.8	Unconfined	5.40	3.35 – 8.01	n/a	600	1.50
WCB-09	Roadside Ditch	n/a	2.16	Partially Confined	14.75	10.19 – 18.68	0.30	600	6.00
WCB-14	Pond D/S	n/a	0.63	Partially Confined	3.60	2.56 – 4.72	n/a	450	1.50
WCB-16	Roadside Ditch	n/a	1.15	Partially Confined	7.00	5.03 – 8.67	0.2	900	3.00
Culvert #10	Pond U/S, Hardening D/S	n/a	0.98	Unconfined	6.26	4.20 – 7.77	n/a	450	1.50

Culvert #14	Hardening U/S and D/S	n/a	0.60	Unconfined	3.90	2.43 – 5.65	0.1	900	1.50
Culvert #44	Pond U/S	n/a	3.20	Unconfined	20.86	15.82 – 24.38	0.19	2 x 750	6.00
Culvert #48	Wetland	n/a	n/a	Unconfined	n/a	n/a	n/a	500	Maintain Existing

Upon detailed design, it is recommended that these minimum crossing spans are utilized using concrete culverts with an open-bottom, functional design. Improved culvert skew and/or channel realignment should be undertaken for those reaches in which flow is primarily restricted to the roadside drainage ditch (WCB-09 and WCB-16).

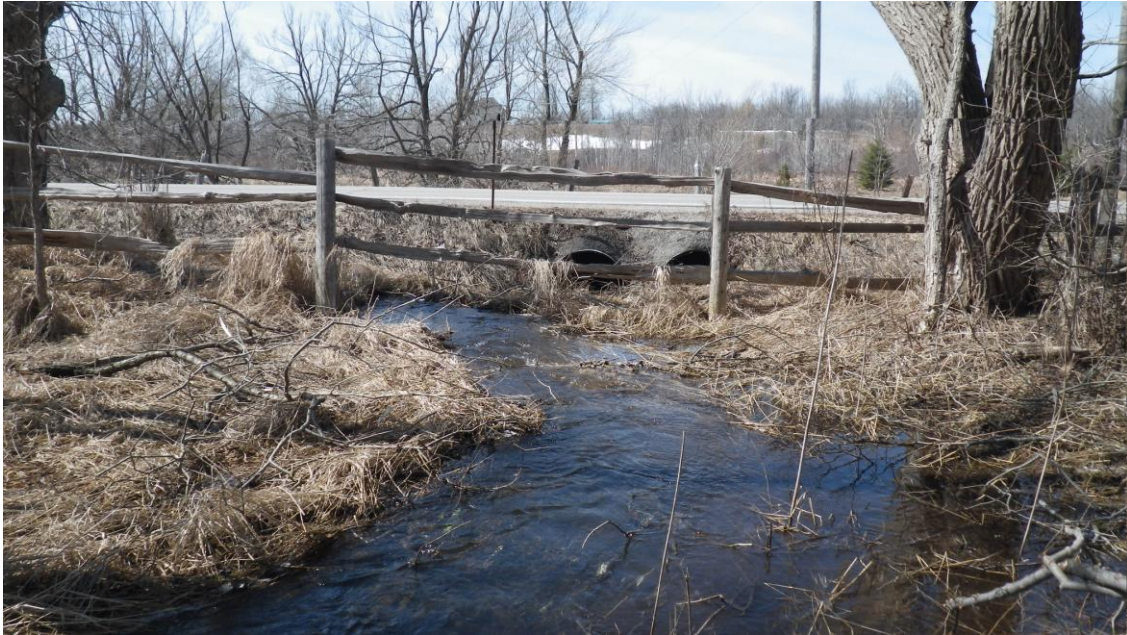
At this stream crossing, Mississauga Road runs overtop of a twin culvert (CSP) where a stream drains a pond 20m upstream and outlets to a marshy area characterized by cattails, eventually connecting with another online pond 40m downstream of the outlet. Upstream, the channel is slightly sinuous with a width of 3.2m, with a depth around 0.37m and is well connected to the floodplain. This steepens within the right of way upon approach to the inlet of the culvert(s). Downstream of the road, the channel widens into a marshy area and backwatering occurs into the culvert outlet. Channel substrates are coarse gravels and cobbles upstream, with finer gravels and sands downstream. Wood debris is present throughout, and a fence crosses the channel at the property line upstream. This channel was found to be relatively stable (in regime), with a score of 0.19, which is close to entering a state of transition. Its primary form of adjustment is in the planform as it becomes a multi thread channel downstream through the wetter area. The stream health is moderate with an RSAT score of 32.

**Photo 1:** View looking downstream towards twin corrugated steel pipe culvert inlets.

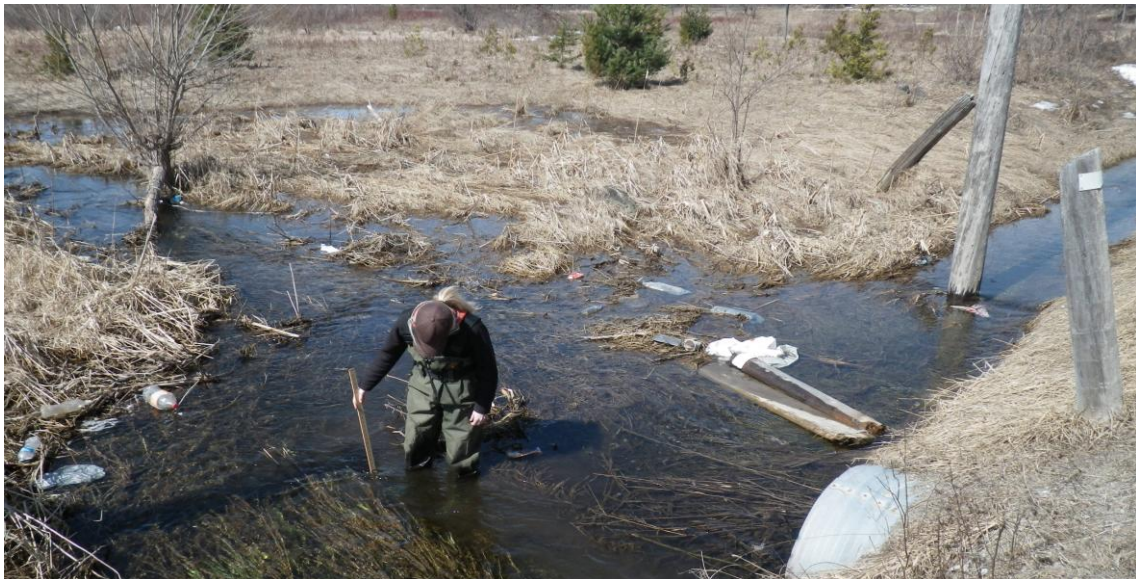
**Photo 2:** View looking downstream of culvert outlet towards marshy area.

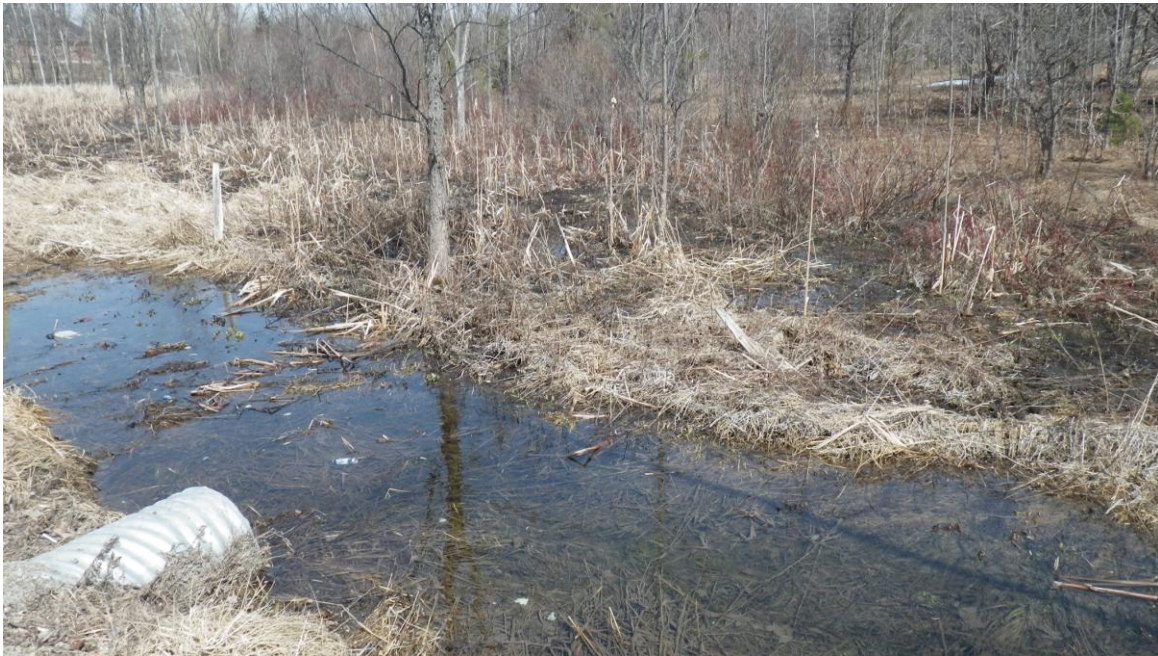
This culvert was bound by wetland marshes with an undefined main channel, with the upstream side identified as a wetland by CVC. Substrates were characteristically fine and the surrounding land was dominated by wetland grasses and deciduous trees and shrubs. Rapid assessments could not be undertaken as a result, and a defined channel could only accurately be identified approximately 100m downstream of the culvert outlet.

**Photo 3:** View looking downstream from culvert inlet where channel is undefined.

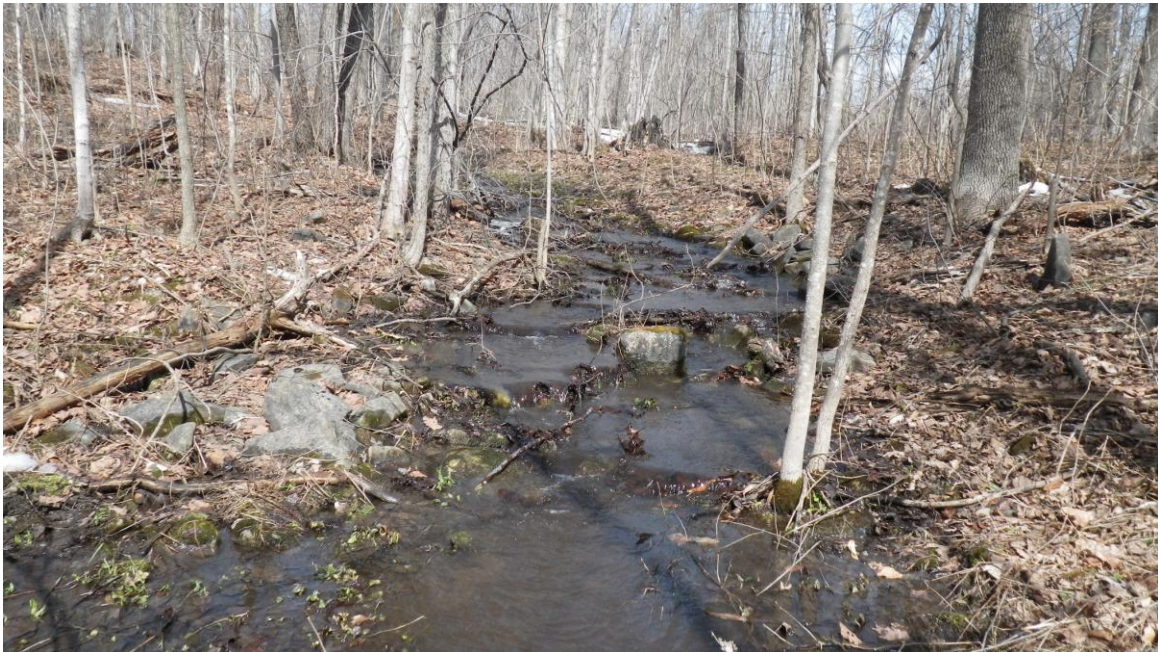
**Photo 4:** View looking upstream. Channel becomes more defined approximately 100metres downstream of culvert crossing.

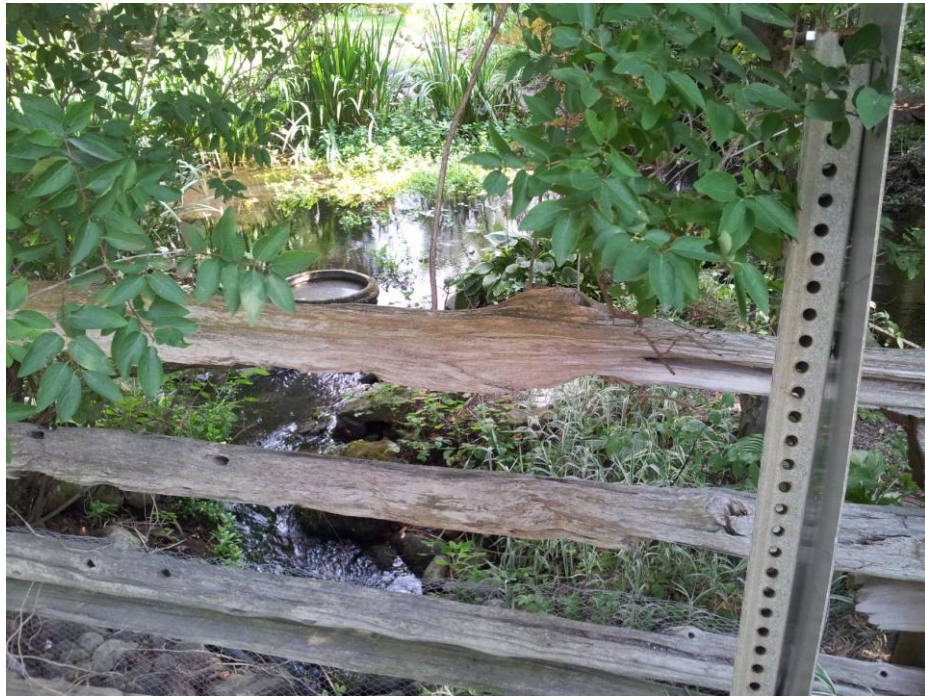
Property access was not gained for this crossing, and rapid assessments were limited to what could be seen within and from the right of way, and in this case, could not be completed. Upstream of the road the watercourse is connected to a landscaped pond and flows into a plastic pipe underneath Bush Street. At the outlet and downstream, cobbles and boulders line the bed and banks, and the channel width is approximately 1.5m up to 2.75m, with a depth of approximately 0.25m.

**Photo 5:** View looking upstream of culvert crossing at online pond.

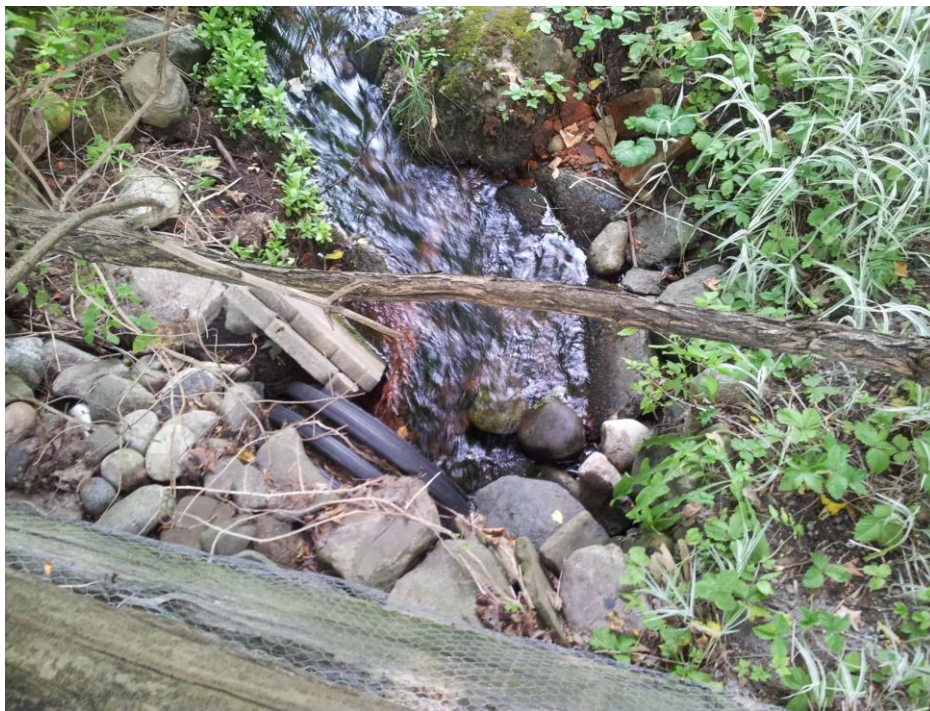
**Photo 6:** View looking just downstream of the online pond at culvert inlet.

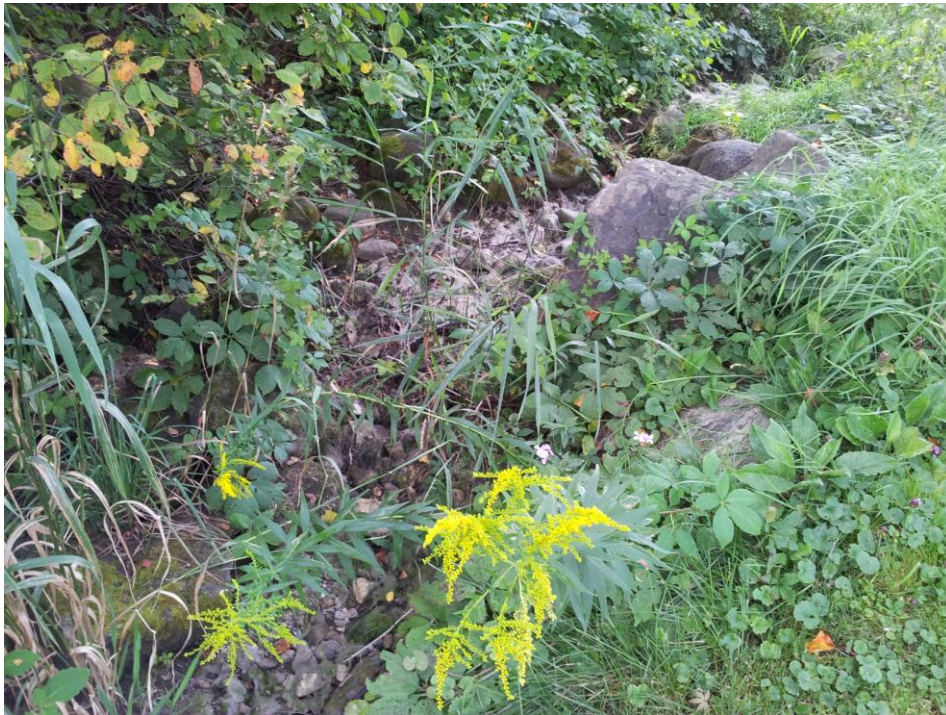
corresponding depths ranging from 0.2 to 0.3m, between the upstream and downstream portions of the reach. Upstream the channel is steep and artificially lined with coarse gravels and cobbles. Downstream, the channel resembles that downstream of Culvert 10, being steep and consisting of cobbles, gravels and boulders. Tree roots were exposed and bank heights increased downstream, indicative of some channel degradation. However, this reach was found to be in regime (stable) with a low RGA score of 0.10. The RSAT could not be completed as it was a dry channel with limited access.

**Photo 7:** View looking upstream of culvert crossing at dry, steep, artificial channel.

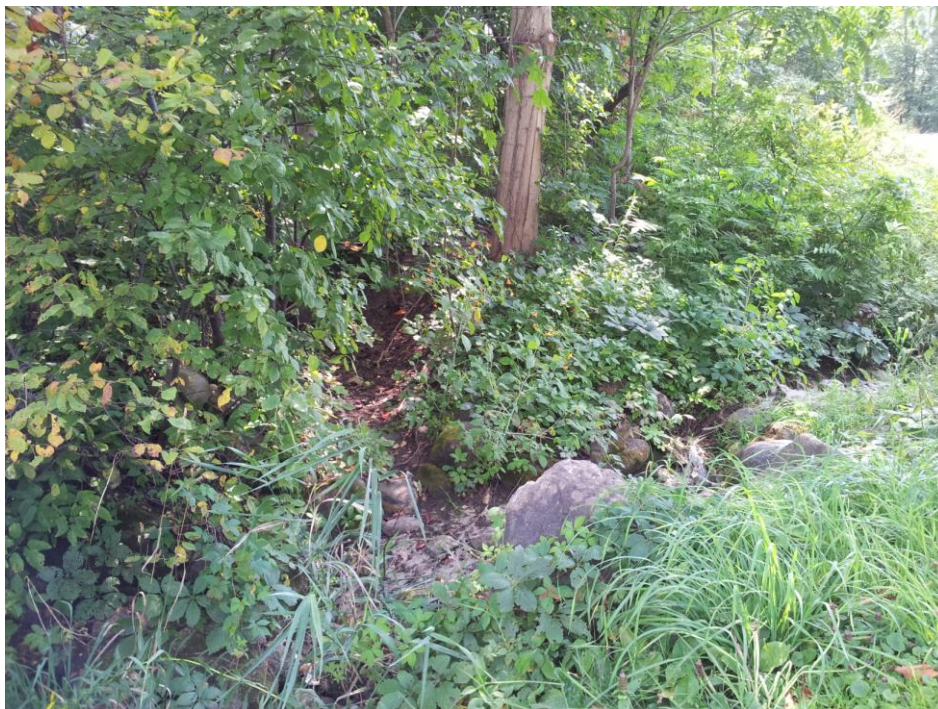
**Photo 8:** View looking downstream of culvert crossing at dry, steep channel.

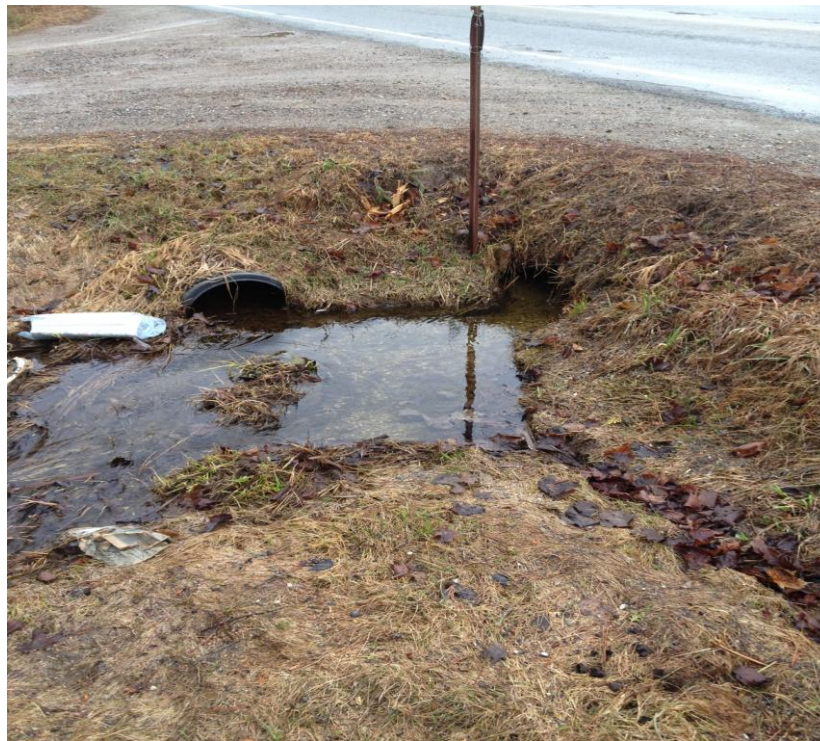
Rapid assessments could not be undertaken for this reach. The upstream side lacked channel definition and has been mapped by CVC as a wetland. Downstream of the culvert outlet, a small stream filled with grasses exists as a ditch for only 15-20m before it is piped through a corrugated steel pipe beneath the property to the West.

**Photo 9:** View looking upstream at culvert outlets.

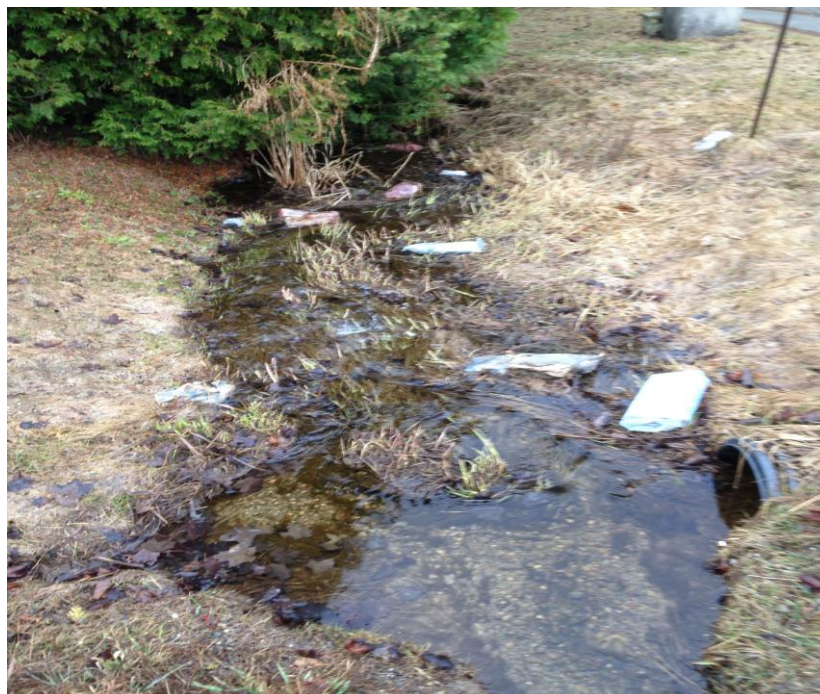
**Photo 10:** View looking downstream of culvert.

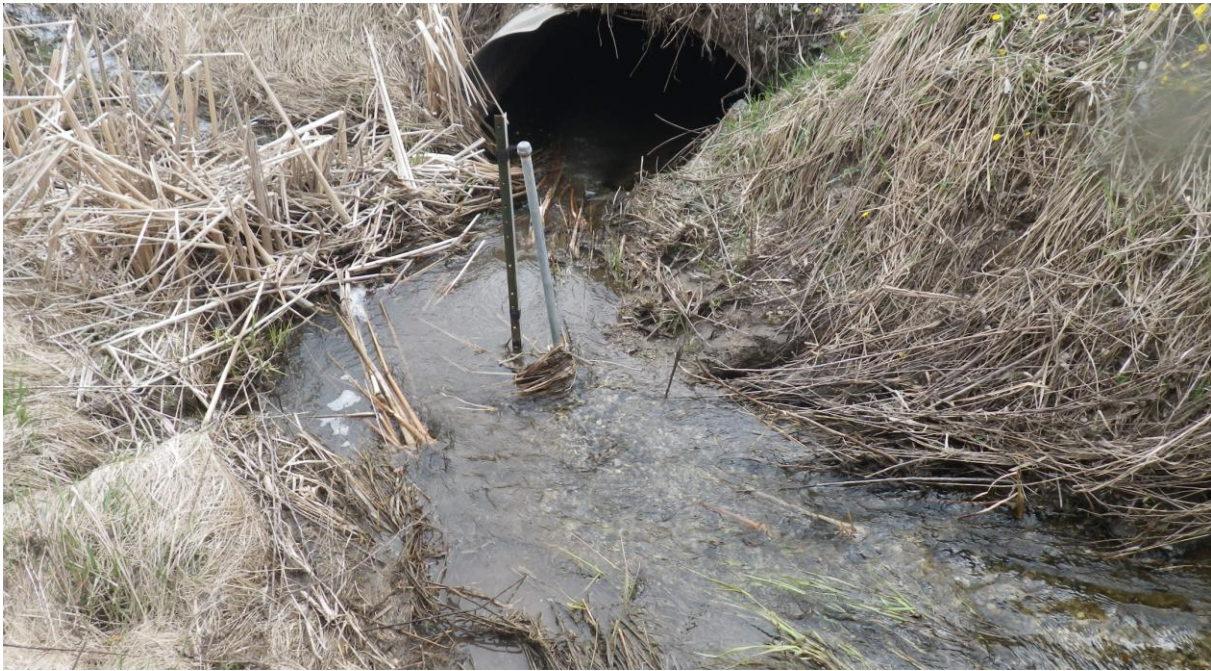
This reach is primarily located within the roadside ditch flowing from the East side of Winston Churchill Boulevard, to the West side in a Southerly direction. It drains agricultural land east of the road through a tributary which leads into the ditch 10m upstream of the culvert inlet. It was apparent upon multiple visits that a natural channel is forming within the roadside ditch which is steep and straight. However, within the constraints of the ditch geometry, a series of knickpoints and alternating zones of bank erosion indicate that the channel is trying to regain some length, and reduce energy (slope). Bankfull widths ranged from 2 to 2.2m, and depths from 0.3 to 0.95m, as bank heights increased downstream but widths were confined to the ditch geometry. Riffles and pools were developing with substrates comprised of medium gravel and coarse sand in the riffles, and silt and sand in the pools. A few lateral bars had also formed, also composed of medium gravel, likely from road fill. Overall, the bed was relatively soft and unconsolidated. At the downstream end of the reach along Sideroad 5, the channel widens and shallows as confinement is reduced where the channel width is 3.35m with a depth of 0.57m. The culvert beneath Winston Churchill runs perpendicular with respect to the flow direction of the ditch, creating some sharp bends at either end. This reach was found to be in a state of transition with an RGA score of 0.30, and degradation as the primary form of adjustment. The stream was found to be moderately healthy with an RSAT score of 25.

**Photo 11:** View looking downstream towards culvert inlet. Level logger is present just upstream of culvert.

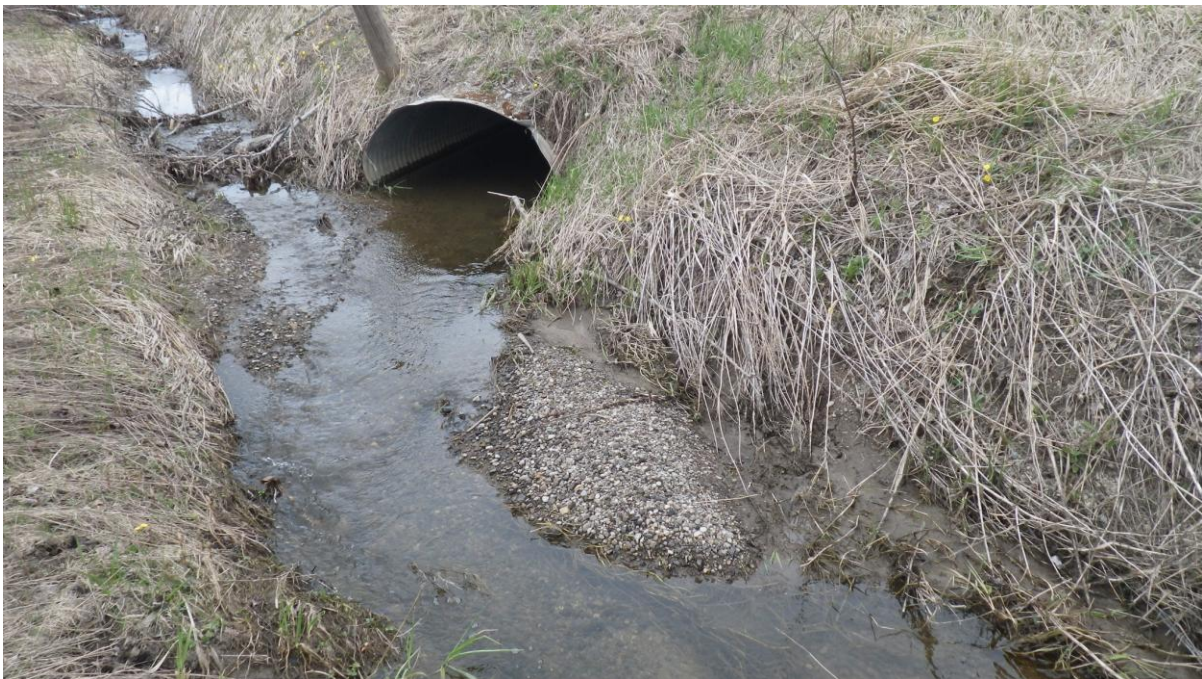
**Photo 12:** View looking upstream towards culvert outlet.

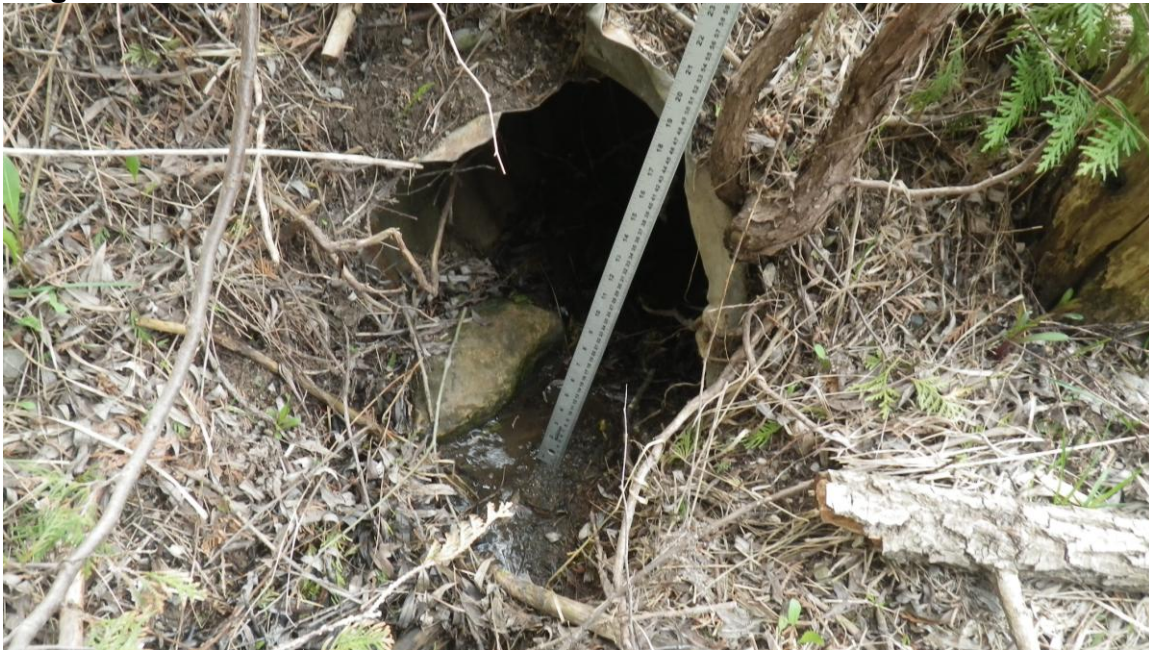
Rapid assessments could not be undertaken for this reach. The upstream side was not flowing during the survey and was poorly defined, and downstream was backwatered with its base level being controlled by an online pond. Although the channel was poorly defined upstream, a width and depth could be estimated 5m upstream of the inlet with a width of

**Photo 13:** View looking downstream towards culvert inlet. Culvert appears to be collapsing.

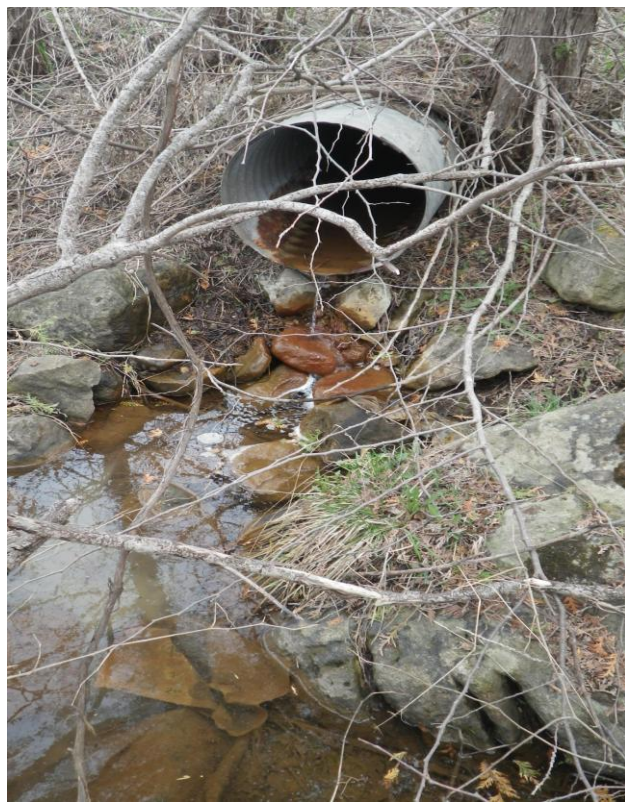
0.63m and a depth of 0.12m. Erosion was evident at the downstream side as the culvert was perched above the water surface by almost 0.5m, and the channel became much wider and deeper: 1.9m and 0.35m, respectively. Rip rap was utilized to stabilize this undercut. There is a notable difference in elevation between the inlet and outlet which likely increases the stream power and velocity under high flow conditions, creating the wider and deeper channel geometry downstream.

**Photo 14:** View looking upstream towards the perched culvert outlet.

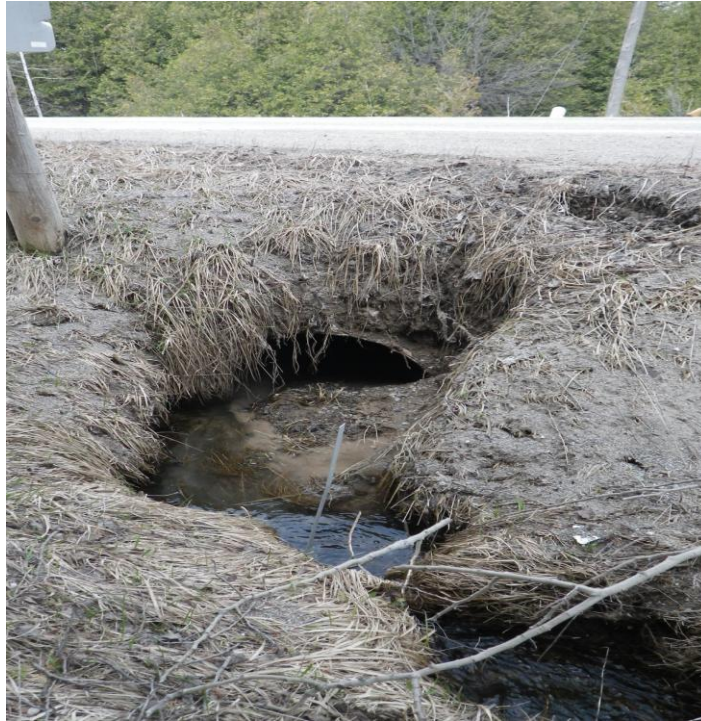
Similar to WCB-09, this reach is primarily located within the roadside ditch, with the culvert perpendicular to the prevailing flow. However, it is draining a smaller area, and initiates in a cedar swamp immediately upstream of the road, resulting in a smaller, more stable channel form. A small, deep channel exists for 2.5m upstream of the culvert, with a steep gradient and two steps and pools as it enters the culvert. The bank along the inlet has failed creating a small deposit, interrupting flow. At the outlet, the channel takes a sharp turn to the north through the drainage ditch, and a lateral bar has developed consisting of pebbles and fine to medium gravels. The channel is only confined along the left bank by the road, and the right there is connection of higher flows to a small marshy area and an online pond further downstream. At the downstream end of the reach (20m down from the outlet) there is a Bell phone utility box with a cobble step 0.3m high in the channel which would likely prevent fish migration upstream. This reach is relatively stable, and in regime, with evidence of aggradation mostly occurring due to the soft, unconsolidated bed. However, the score of 0.2 suggests that this reach may become more unstable and reach a state of transition. The RSAT score was moderate but rather low with a score of 21.

**Photo 15:** View looking upstream towards culvert inlet which is being compromised by the failing bank.

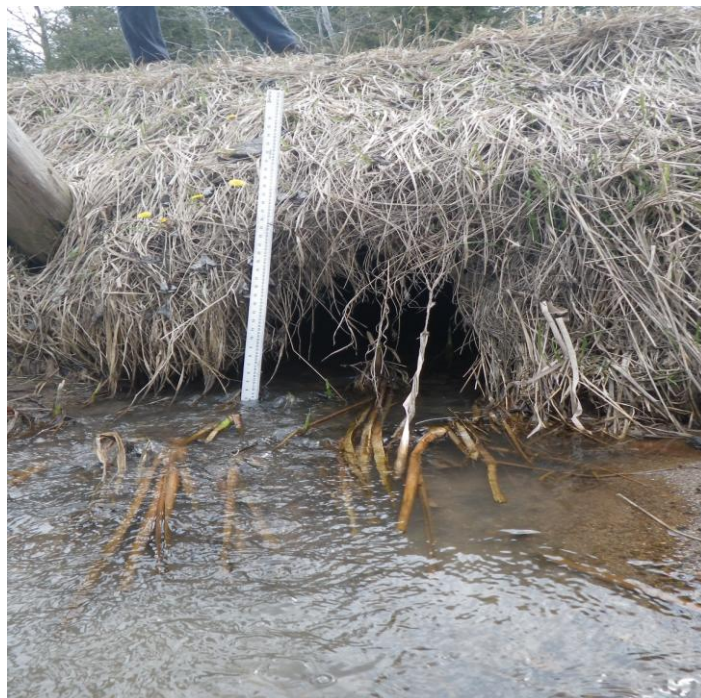
**Photo 16:** View looking upstream towards culvert outlet which is being compromised due to slumping bank.

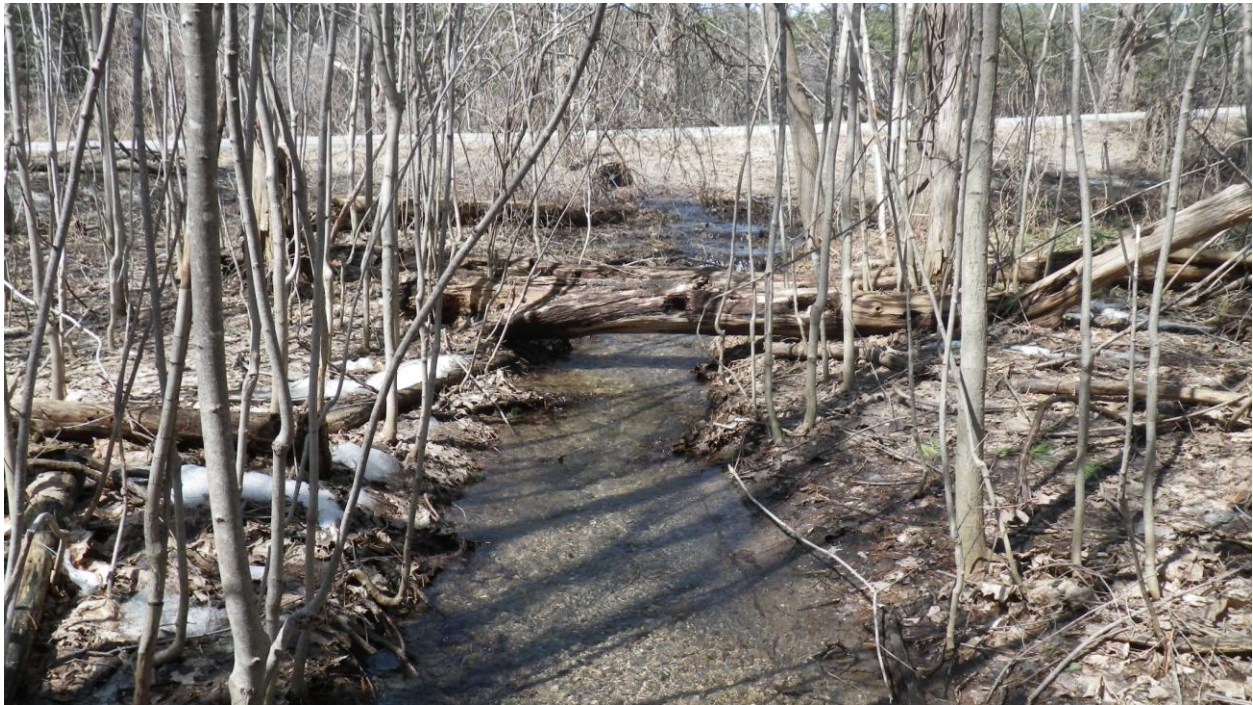
Upstream of the crossing, a pond had developed amongst some deciduous trees presumably due to recent melt. The channel remained undefined for approximately 100m upstream where a width of 1.5m and depth of 0.25m were measurable. On the downstream side, the channel grade steepened upon exiting the culvert into a single thread channel flowing over carbonate cobbles and boulders, forming a series of steps, characteristic of many streams on the Niagara Escarpment. Approximately 200m downstream the channel became multi-threaded through a cedar swamp. The substrate was comprised of silt, pebbles, and gravel, with cobbles occurring throughout. The stream was found to be in a transitional state with an RGA score of 0.26, with evidence of all forms of adjustment occurring. Aggradation was found upstream, and degradation, widening, and planform adjustment downstream of the culvert. Stream health (RSAT) scores were moderate with a value of 31.

**Photo 17:** View looking upstream towards culvert outlet.

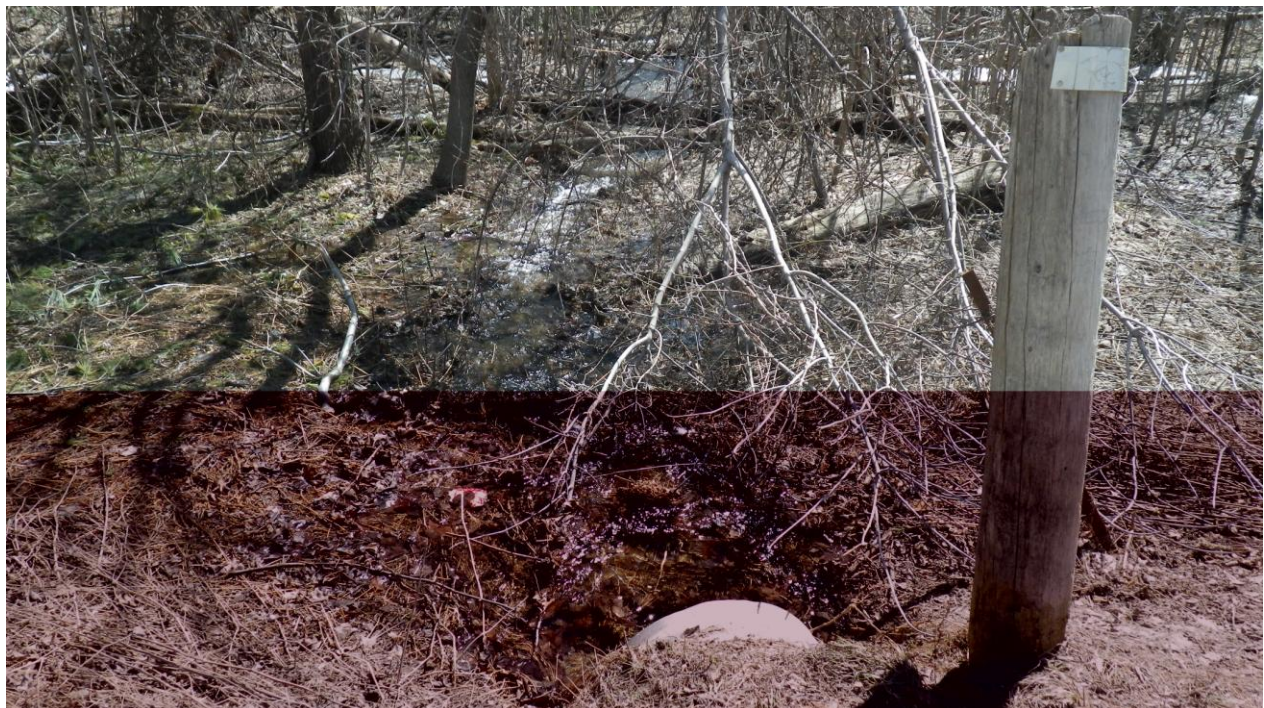
**Photo 18:** View looking upstream of culvert inlet.

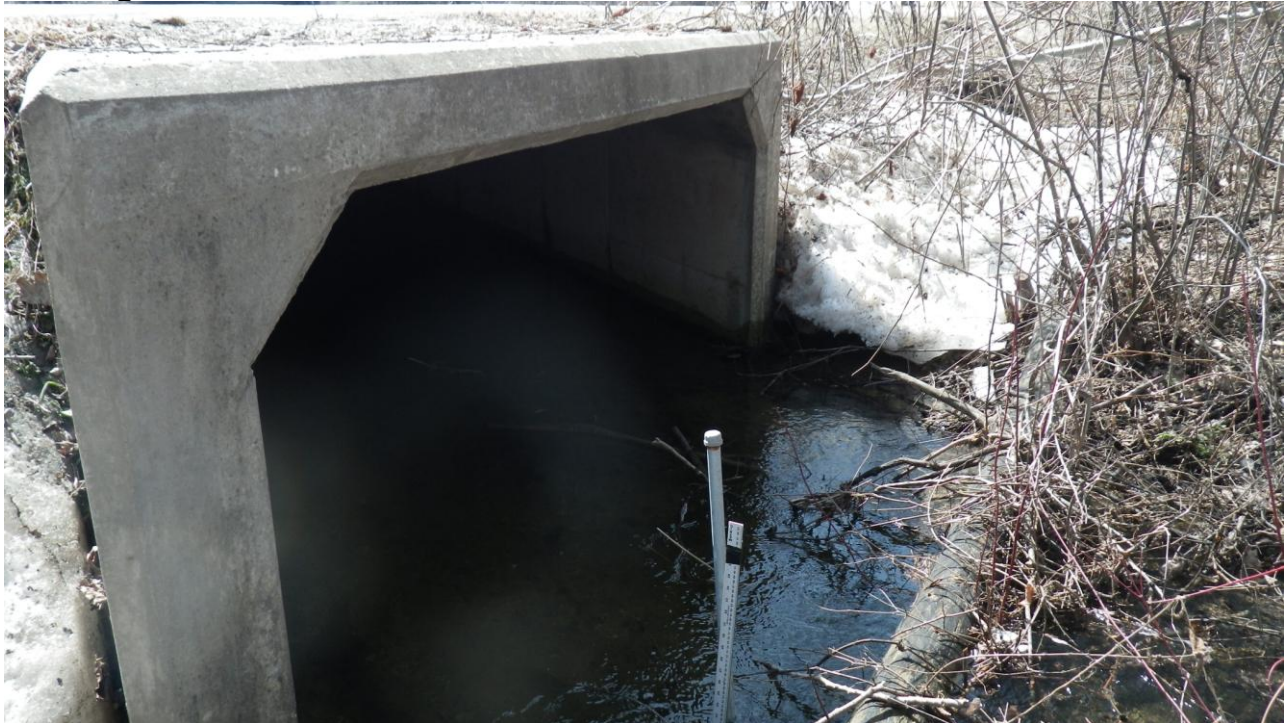
Within the study area, this reach is one of the more significant watercourses, with water permanently flowing, and a concrete box culvert with a span of over 3m. The channel form is relatively straight, intersecting with Olde Base Line Road at approximately a 45° angle. It flows between a grassy field and a private pond, with deciduous trees lining the banks. Major woody debris occurs throughout and the bedform is dominated by a series of pools and jams, with unconsolidated gravels, sands, and silt depositing along the bed. Bankfull widths ranged from 1.8-4m, and depths from 0.33 to 0.71m. Bank heights increased downstream towards the road, and gravelly substrate lines the bed of the channel through the concrete culvert structure. The form and function of the channel can be identified as being in a state of transition with an RGA score of 0.31 and aggradation as the primary form of adjustment. Stream health was determined to be moderate with a score of 28.

**Photo 19:** View looking downstream at culvert inlet. Level logger is present just upstream of culvert.

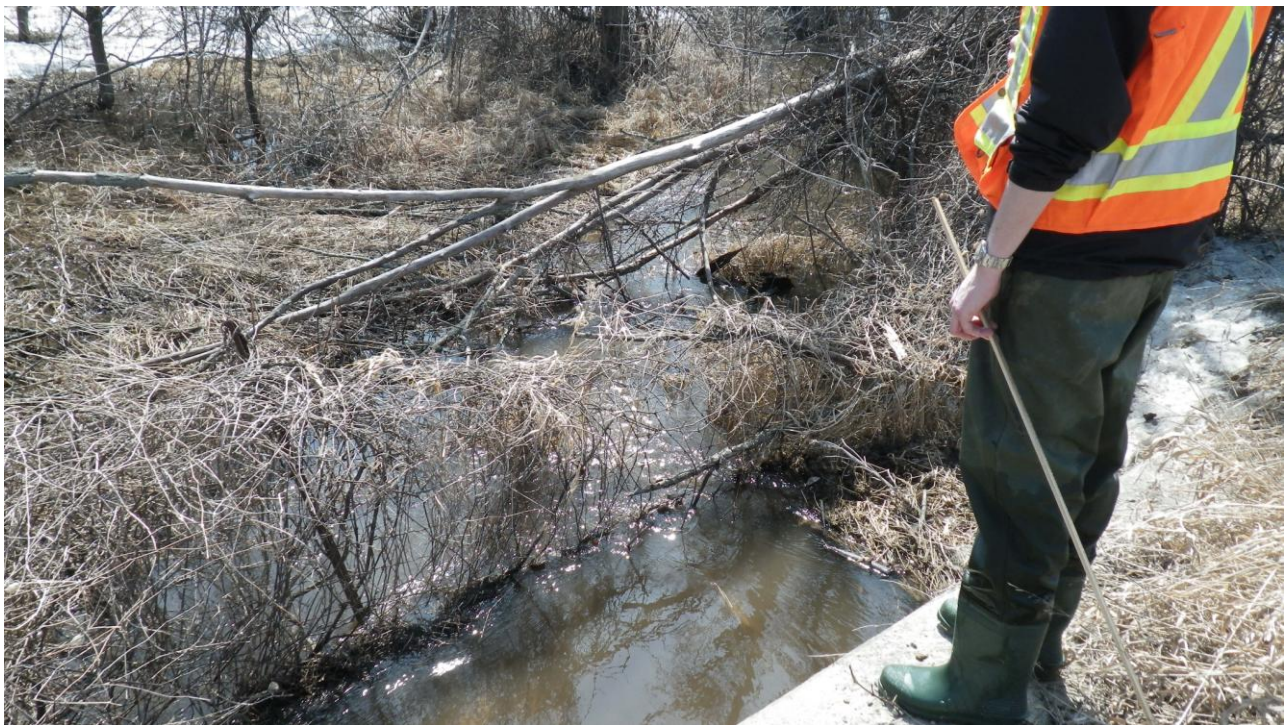
**Photo 20:** View looking downstream from culvert outlet.

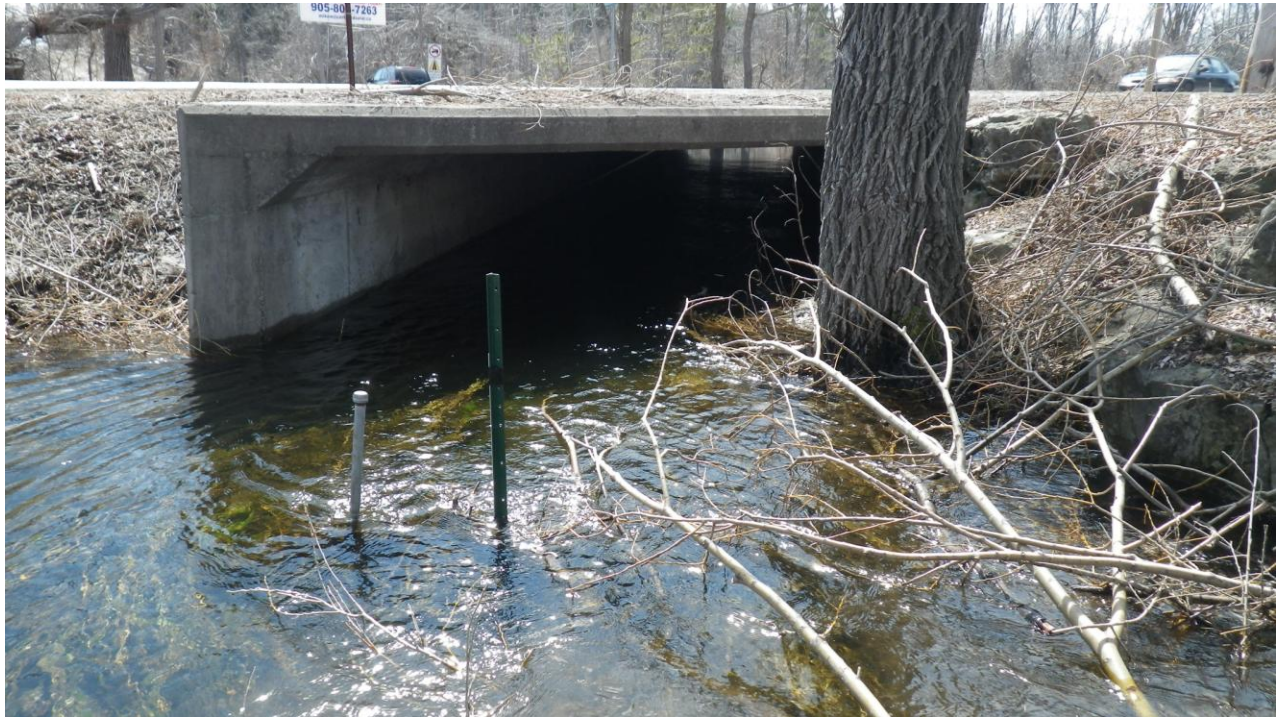
This watercourse was the only other within the study area that was major enough to require a relatively large crossing span (4.5m), also a concrete box culvert structure. It flows out of an online pond at the upstream end through a riparian zone dominated by deciduous trees,

with major wood debris occurring. At the time of the survey, a late spring freshet was underway, creating overbank flooding. Despite this, bankfull features were visible below the water surface and inflections within the cross-section could be felt in order to estimate the bankfull channel dimensions. Bankfull widths were in the 3m range, and depths around 0.31m. Like OBL-04, the bed was comprised of unconsolidated gravels and sands. This reach is also in a state of transition with aggradation as the primary form of adjustment with an RGA score of 0.24. Stream health was determined to be moderate with a score of 28.

**Photo 21:** View looking downstream towards culvert inlet. Level logger is present just upstream of culvert.
