**FINAL REPORT**

# **Caledon Road Improvements EA – Geomorphic Assessment**

Date: May 2014

**Project name:** Caledon Road Improvements EA

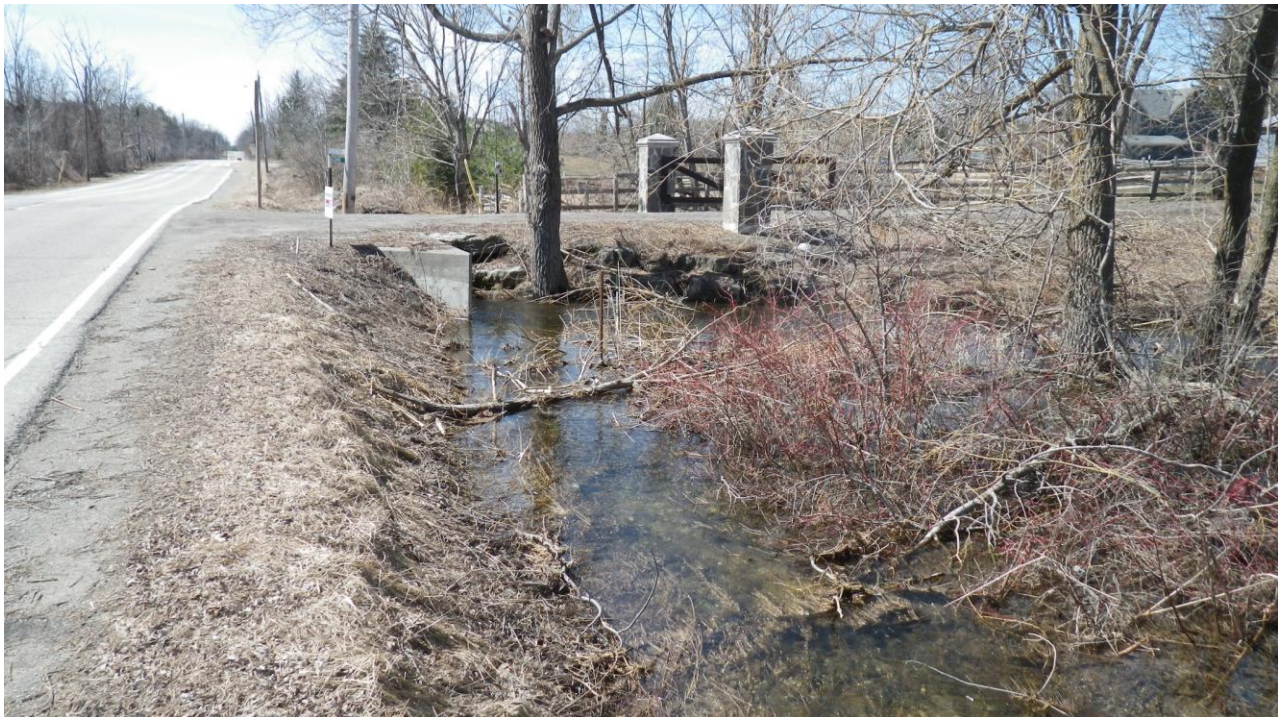
This watercourse was the only other within the study area that was major enough to require a relatively large crossing span (4.5m), also a concrete box culvert structure. It flows out of an online pond at the upstream end through a riparian zone dominated by deciduous trees,

with major wood debris occurring. At the time of the survey, a late spring freshet was underway, creating overbank flooding. Despite this, bankfull features were visible below the water surface and inflections within the cross-section could be felt in order to estimate the bankfull channel dimensions. Bankfull widths were in the 3m range, and depths around 0.31m. Like OBL-04, the bed was comprised of unconsolidated gravels and sands. This reach is also in a state of transition with aggradation as the primary form of adjustment with an RGA score of 0.24. Stream health was determined to be moderate with a score of 28.

**Photo 22:** View looking downstream of roadside ditch which drains into culvert inlet.
