Appendix C

**Mississauga Road / Old Main Street
and Bush Street**

**Stage 1 Archaeological Assessment
(Background Research and Property Inspection)**

**Mississauga Road Improvements from Olde Base Line Road to Bush Street and
Bush Street From Mississauga Road to Winston Churchill Boulevard
Class Environmental Assessment,
Regional Municipality of Peel, Ontario**

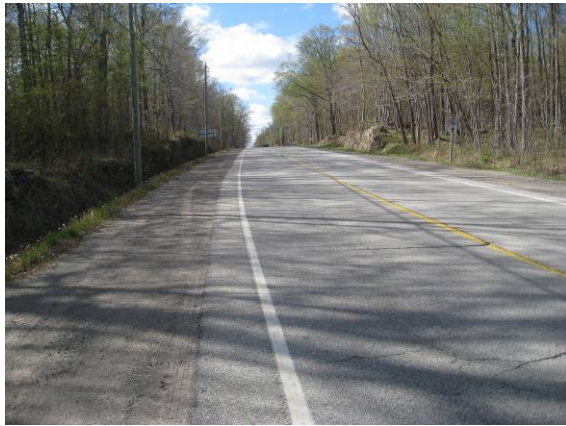
Plate 1: View northwest along Mississauga Rd. Lands adjacent to ROW consists of rocky, uneven ground.

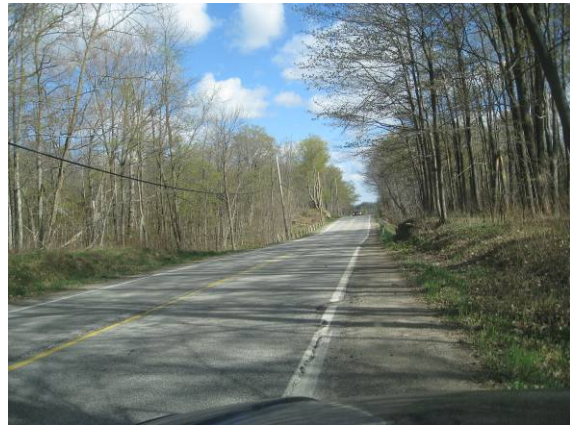
Plate 2: View southeast along Mississauga Rd ROW. Lands adjacent to ROW consists of rocky, uneven ground.

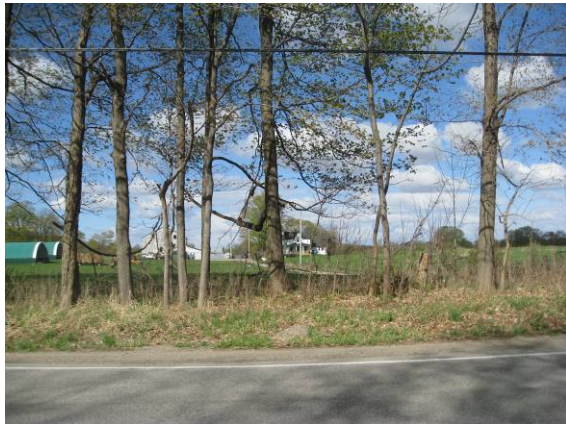
Plate 3: View northeast toward 19th century farm. Undisturbed lands are present beyond tree line in agricultural field..

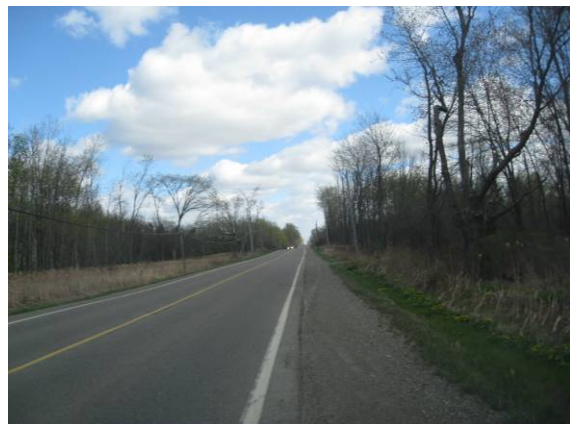
Plate 6: View southeast along Mississauga Rd. Note lands adjacent to ROW are low/wet.

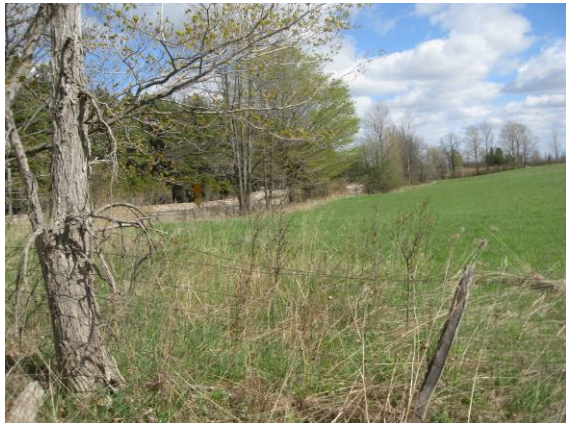
Plate 7: View southeast across open agricultural field.

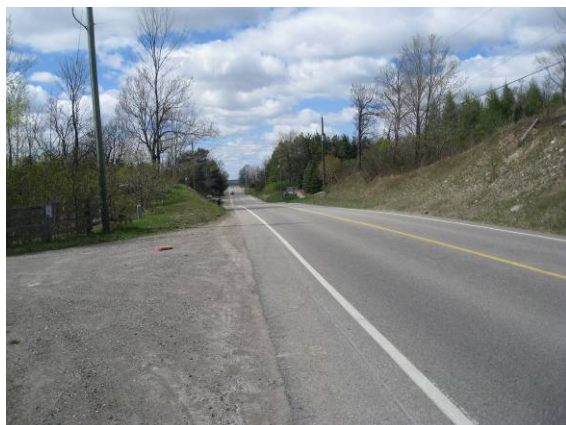
Plate 11: View northwest along Mississauga Rd. Note steep slope adjacent to ROW.

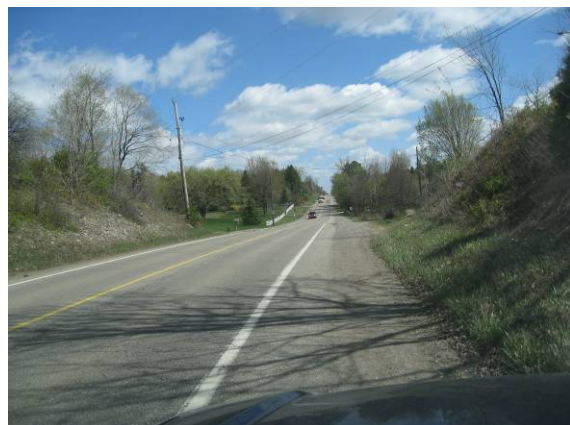
Plate 12: View southeast along Mississauga Rd. Note steep slope adjacent to ROW.

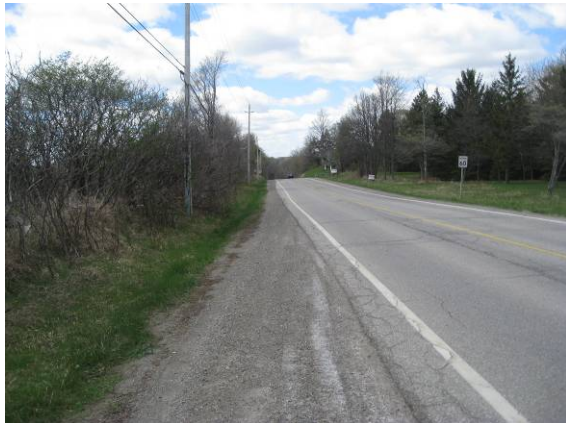
Plate 13: View northwest along Mississauga Rd. Undisturbed land is present on either side of ROW.

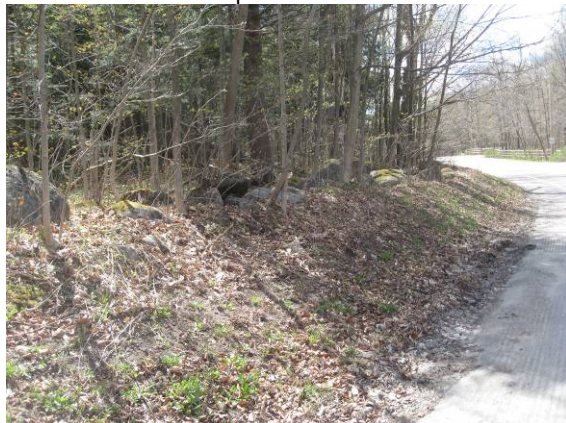
Plate 15: View west-northwest at rough rocky terrain.

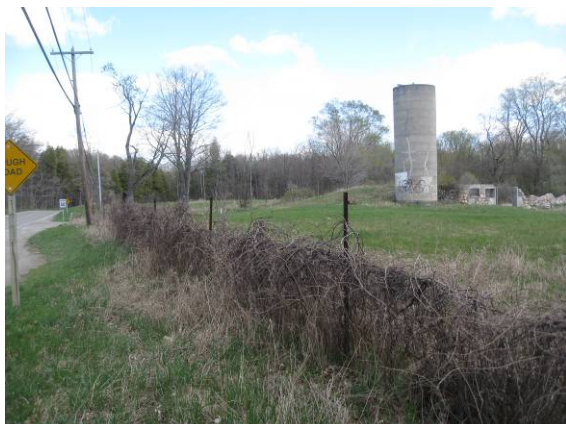
Plate 17: View east at undisturbed area.

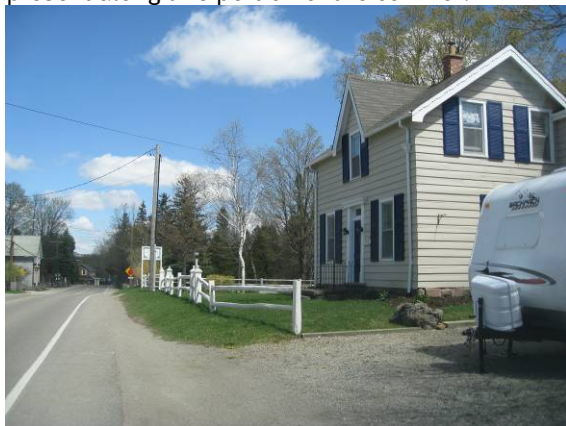
Plate 21: View east toward 19th century residence in Belfountain. Archaeological potential is present on front lawn.

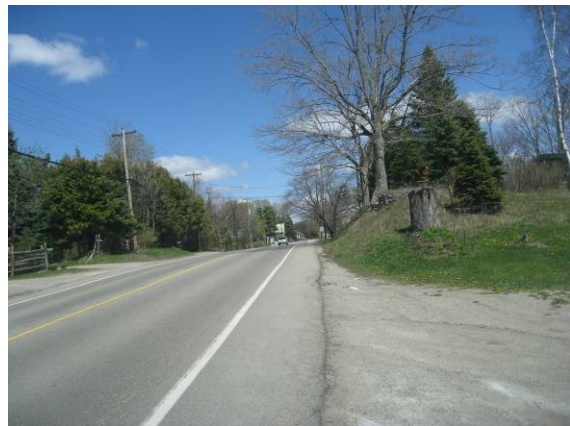
Plate 22: View northeast along Bush St. ROW. Note wide gravel shoulders. Lands adjacent to ROW are sloping or low/wet.

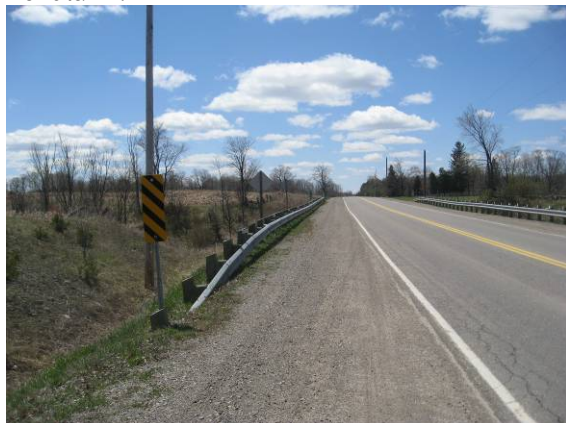
Plate 23: View south-southwest along Bush St. ROW. Open agricultural field in far distance has archaeological potential.

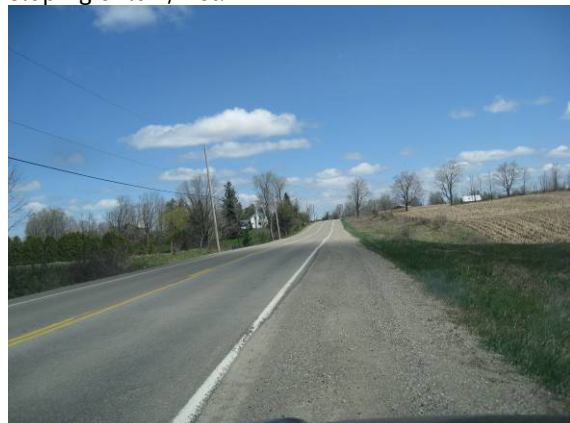
Plate 24: View northeast along disturbed ROW. Potential exists in agricultural field.

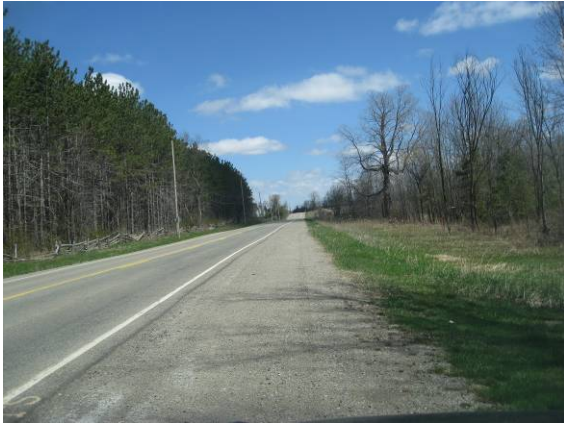
Plate 25: View northeast along wide ROW. Adjacent woodlot is low/wet.

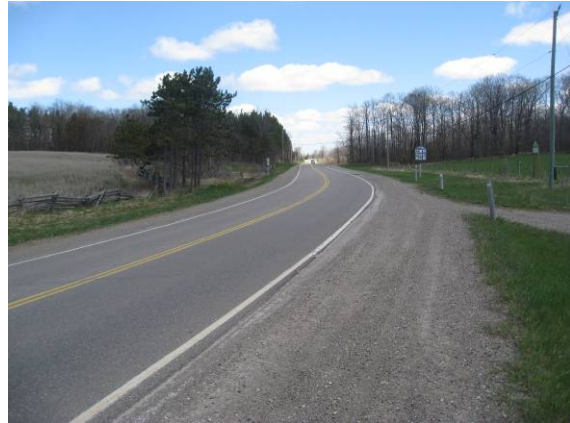
Plate 26: View northeast at graded ROW. Potential exists in agricultural field on both sides of road.

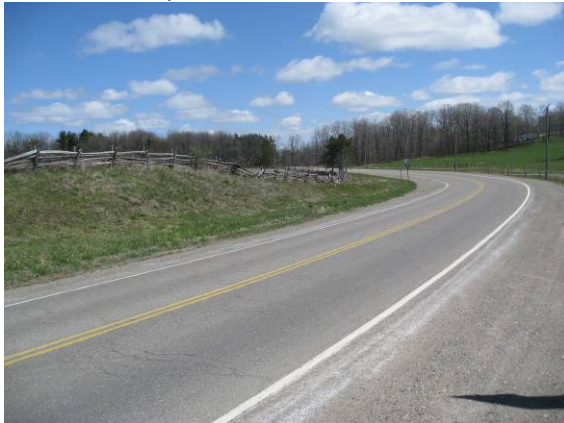
Plate 27: View northeast along Bush St. Potential exists on other side of road cut on left.

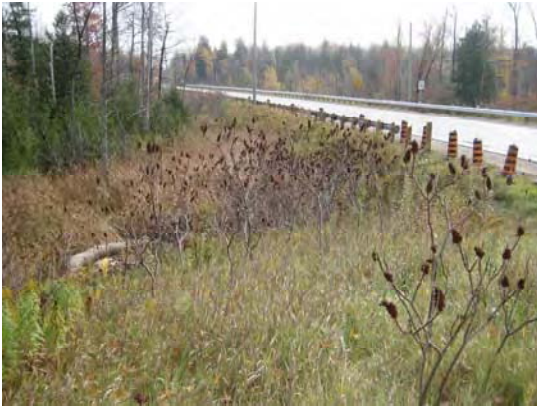
Plate 1: South-southeast view towards Mississauga Road. Area is low and wet – no potential.

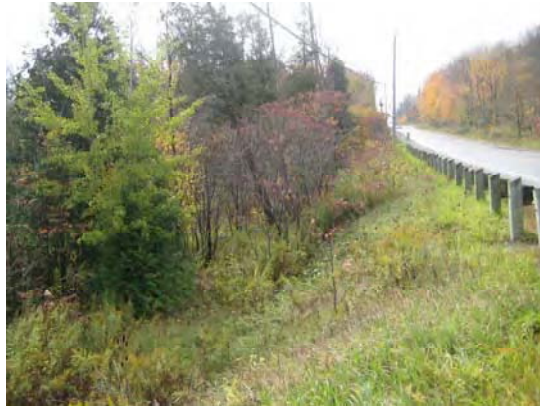
Plate 2: South-southwest view along OldeBase Line Road. Raised road bed across low/wet ground. No potential.

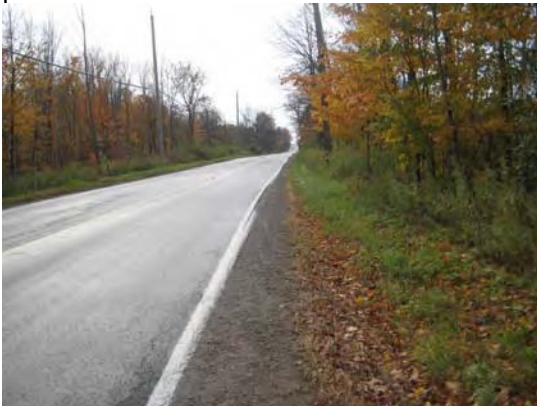
Plate 3: Southwest view along Olde Base Line Road. ROW is disturbed and has no potential. Potential beyond ROW in level lands.

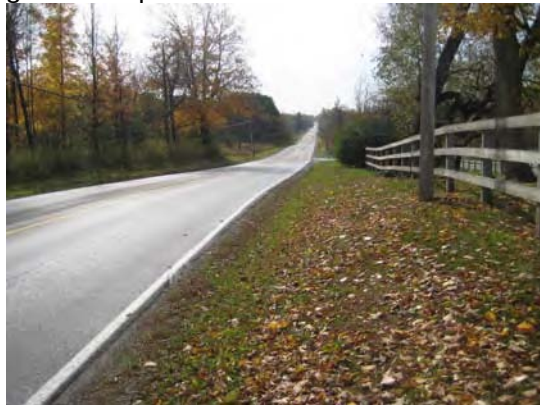
Plate 4: North-northeast view along Olde Base Line Road. ROW is disturbed – no potential. Potential on both sides of road beyond ROW. Note sloping ground in distance.

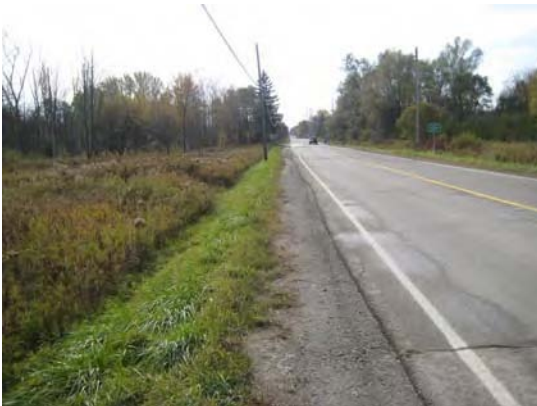
Plate 5: South-southwest view along Olde Base Line Road. ROW is artificially raised and disturbed – no potential. Low and wet on both sides of road.

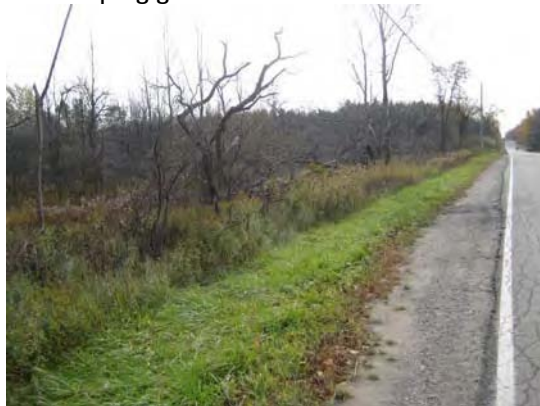
Plate 6: Southsouthwest view from Olde Base Line Road. ROW and low/wet conditions – no potential.

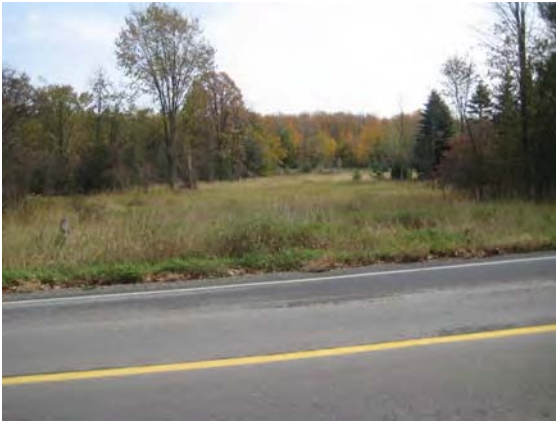
Plate 7: Southeast view into wetland on south side of Olde Baseline Road. Disturbed ROW and low/wet conditions – no potential.

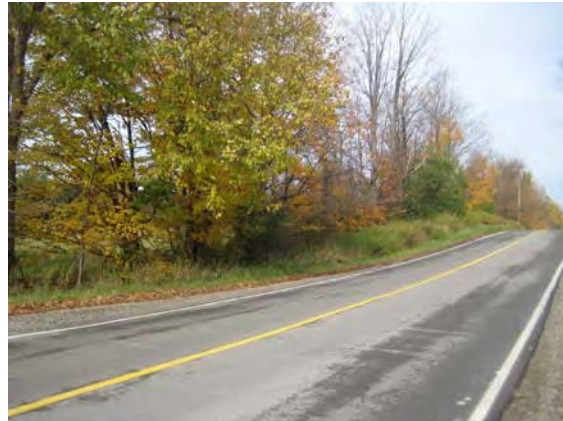
Plate 8: North view from Olde Baseline Road. Potential on ridge. No potential in ROW or in low/wet areas adjacent to creek.

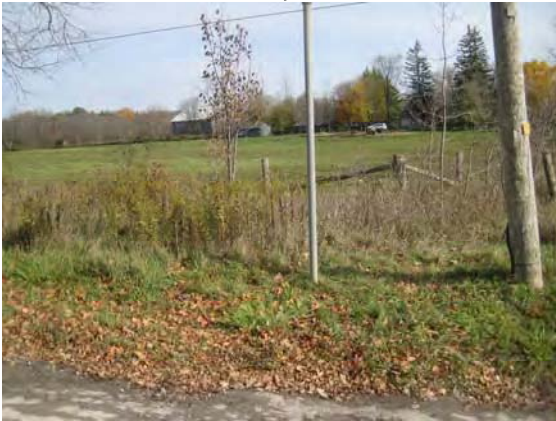
Plate 9: Southeast view from Olde Baseline Road. Potential in open green space. Note historic farmstead in distance.

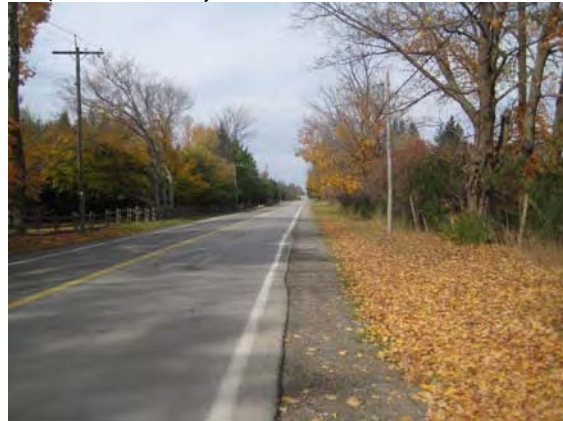
Plate 10: Northwest view along Winston Churchill Boulevard. ROW is disturbed – no potential. Potential on both sides of road beyond ROW.

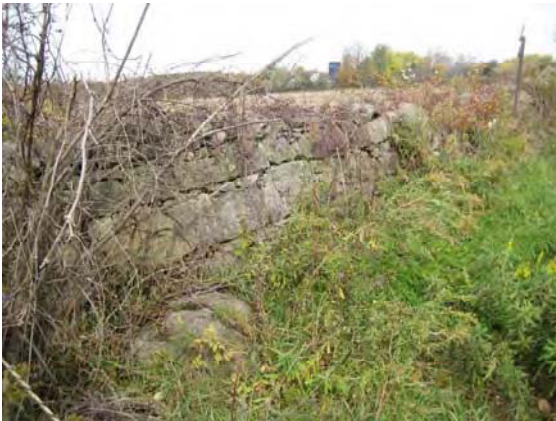
Plate 11: North view from Winston Churchill Boulevard. Dry stone wall on at the edge of a historic farmstead. Potential on both sides of road.

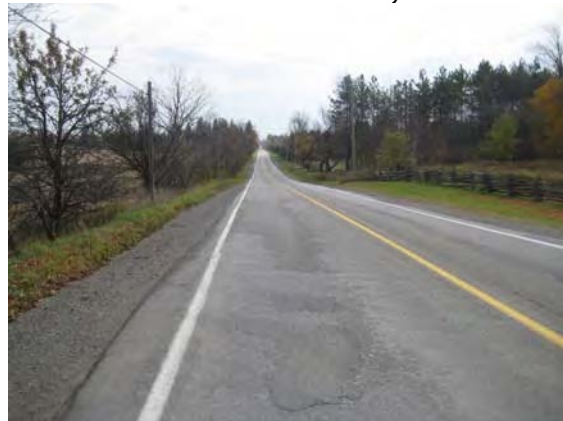
Plate 12: Southeast view along Winston Churchill Boulevard. ROW is disturbed – no potential. Potential on both sides of road beyond ROW.

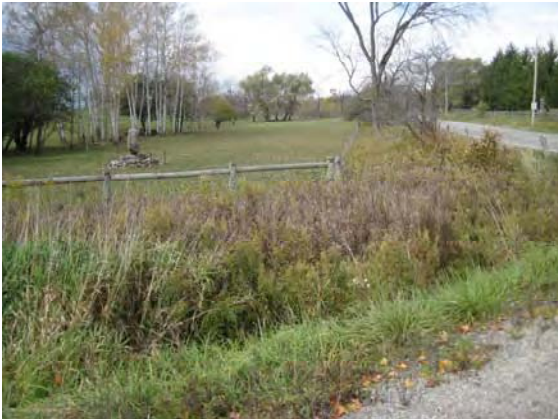
Plate 13: Northwest view from 5th Sideroad. ROW and ditch are disturbed – no potential. Potential in open field beyond fence line.

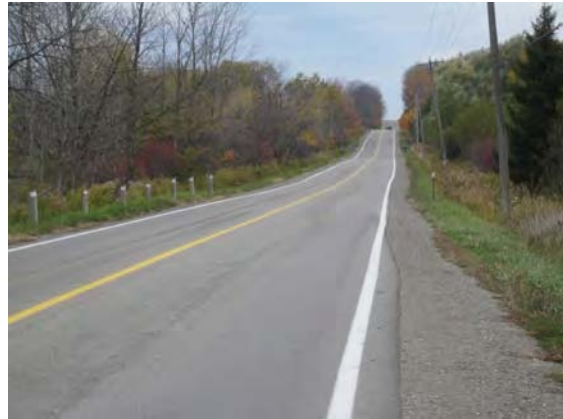
Plate 14: Northwest view along Winston Churchill Boulevard. Low/wet land on both sides of raised road bed. Potential adjacent to ROW along fence line.

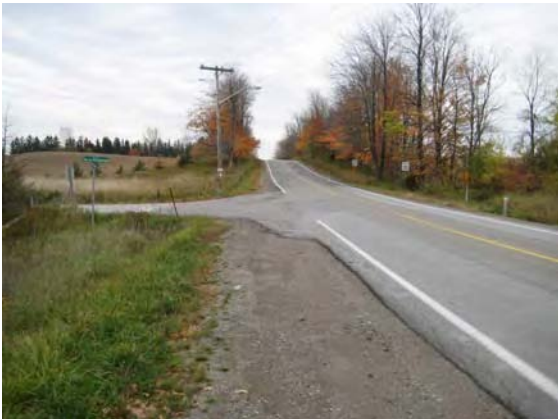
Plate 15: Southeast view along Winston Churchill Boulevard. Low/wet land on both sides of road – no potential. Note rise in distance.

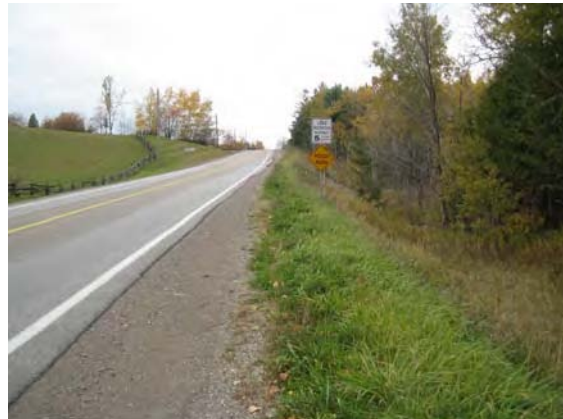
Plate 16: Northwest view along Winston Churchill Road. Low/wet land on right - no potential. Note higher land with potential in distance on left.

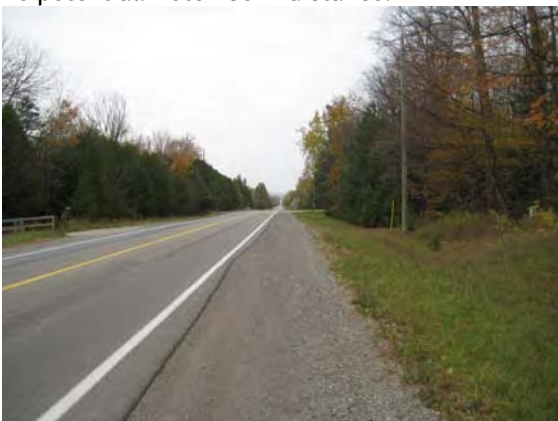
Plate 17: Northwest view along Winston Churchill Boulevard. ROW is disturbed – no potential. Potential on both sides of road beyond ROW.

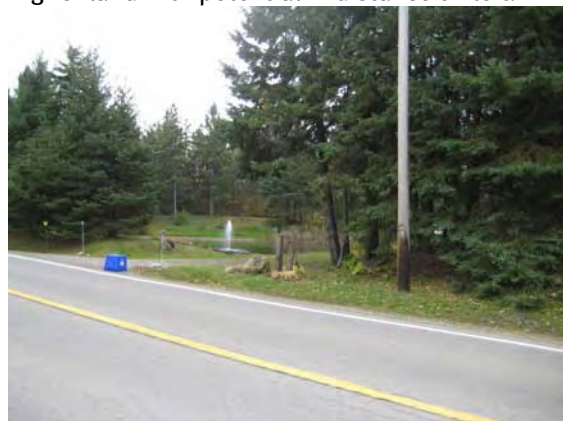
Plate 18: South view of Winston Churchill Boulevard. ROW is disturbed – no potential. Note small kettle pond in distance.

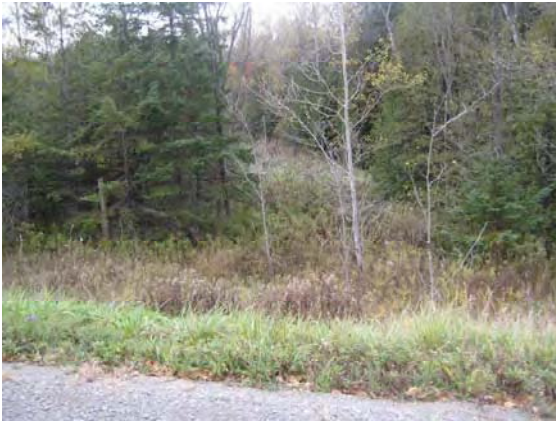
Plate 19: South-southwest view from Winston Churchill Boulevard. Area is low and wet due to presence of kettle lakes/ponds and wetland – no potential.

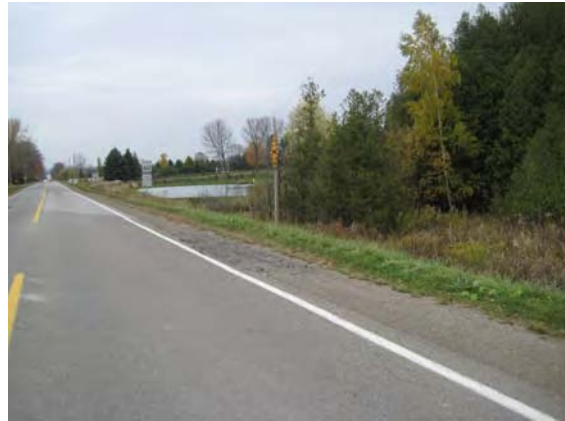
Plate 20: North-northwest view along Winston Churchill Boulevard. Disturbed ROW and kettle pond with associated wetland – no potential.

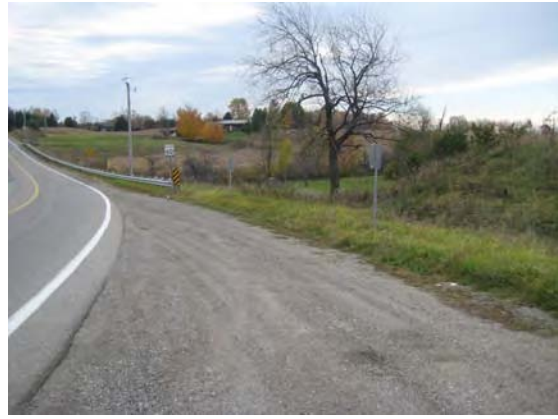
Plate 22: South view from Winston Churchill Boulevard towards wetland and ravine. No potential due to ROW disturbance and low/wet conditions.

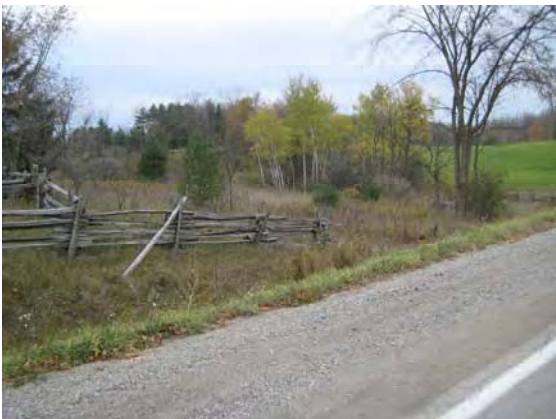
Plate 23: Northeast view from Winston Churchill Boulevard. Low/wet and sloping beyond road. No potential.

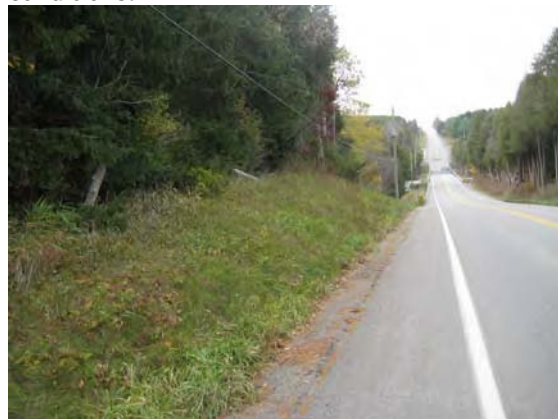
Plate 24: Northwest view along Winston Churchill Boulevard. ROW is disturbed – no potential. Note steep slope to right and in distance.

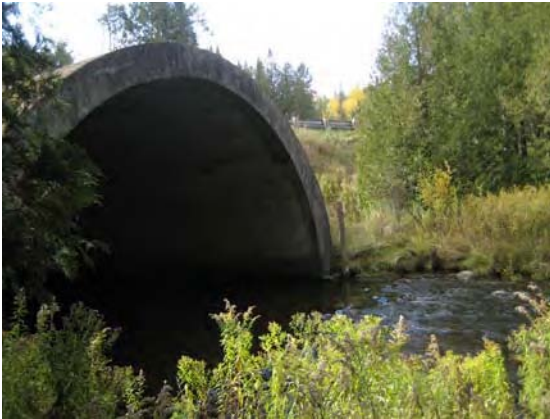
Plate 25: West-southwest view towards Winston Churchill Boulevard. Area around concrete culvert is disturbed – no potential. No potential in valley due to low/wet and steeply sloping conditions.

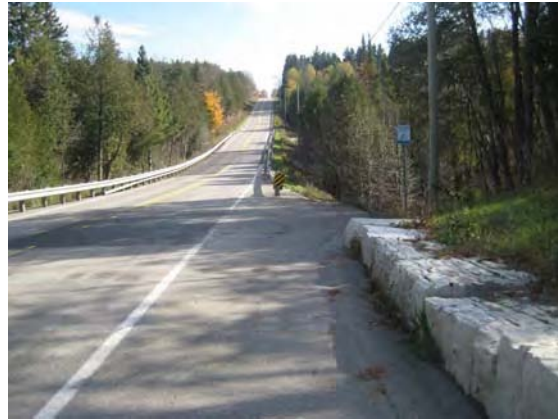
Plate 26: Southeast view along Winston Churchill Boulevard across valley. Road is raised above valley floor/steeply sloping lands. No potential.

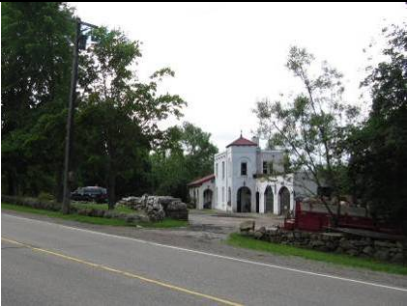
BHR 2	16014 Mississauga Road	Residence	Mid-twentieth century Spanish Colonial residence; central part is 2 storeys with flat roof; 1 ½ storey accretion to the south with gable tile roof; unknown foundation and stucco cladding; 2 chimneys (internal and external); tower on the northwest corner of the central part features an arcaded entrance; the structure is positioned at an angle to the ROW; garage is attached on the north elevation.	Identified during the field review

Indirect impacts to this resource may occur as a result of encroachment on to this property

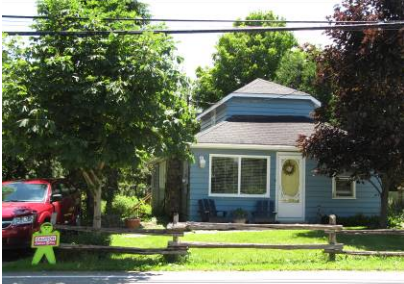
BHR 5	17170 Old Main Street	Residence	Early twentieth-century 1 ½ storey structure; ½ storey addition on the front façade; unknown foundation; vinyl siding; hipped asphalt roof; modern windows.	<i>Listed:</i> Inventory ID 257, Town of Caledon

Indirect impacts to this resource may occur as a result of encroachment on to this property

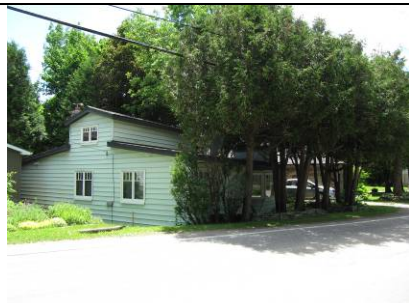
BHR 8	17190 Old Main Street	Residence	Mid twentieth-century vernacular residence; 1 ½ storeys; unknown foundation; vinyl siding; gable asphalt roof; modern casement windows with 3/1 panes; enclosed front porch is present.	<i>Listed:</i> Inventory ID 254, Town of Caledon

Indirect impacts to this resource may occur as a result of encroachment on to this property.

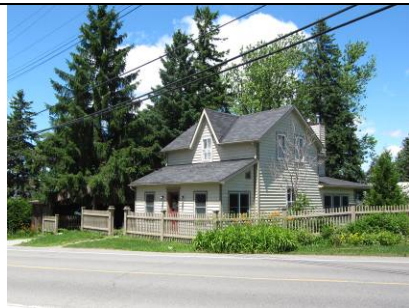
BHR 11	17211 Old Main Street	Residence	Nineteenth century Ontario Gothic cottage; 1 ½ storeys; unknown foundation; combination of wood and vinyl siding; hipped asphalt roof; original 4-pane storm windows on west elevation; new windows on enclosed front porch exterior, which was likely a later addition.	<i>Listed:</i> Inventor ID 251, Town of Caledon

Indirect impacts to this resource may occur as a result of encroachment on to this property.

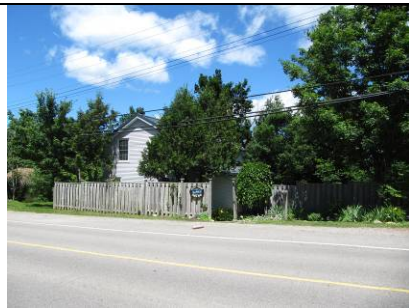
BHR 14	17241 Old Main Street	Residence	Brock Residence; c.1840; 1 ½ storey frame structure; wood clapboarding; gable asphalt roof; the structure faces south away from the road; modern windows; first residence on Main Street; built by Robert Western Brock, cabinet and casket maker; house drawn by C.W. Jeffreys in 1933.	<i>Designated:</i> Inventory ID 244, Town of Caledon (also in Scheinman 2009: 7-38, BC-12)

Indirect impacts to this resource may occur as a result of encroachment on to this property.

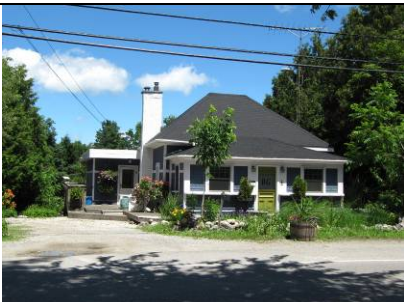
BHR 17	17263 Old Main Street	Residence	Early twentieth century; 1 storey with 1 storey rear addition; unknown foundation; hipped asphalt roof with steeply sloped roof line; wood cladding; single internal chimney; enclosed front porch; modern windows on the west elevation; excellent integrity/condition.	<i>Listed:</i> Inventory ID 240, Town of Caledon

Indirect impacts to this resource may occur as a result of encroachment on to this property.

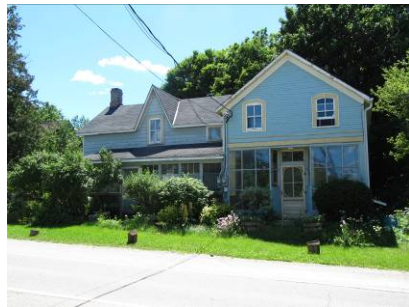
BHR 20	17246 Old Main Street	Residence; commercial	McTaggart-Douglas House and Store; aka Wayside Inn; c.1850; 1 1/2 storey frame structure with clapboard exterior; High Victorian Gothic style; front gabled north wing with early shopfront; a verandah is extant; original segmentally arched windows and corbelled brick chimneys extant; operated by Peter McTaggart in mid-1850s as a store and inn; a barn located to the south and set further back from ROW; the barn has a gable roof and vertical board siding.	<i>Designated:</i> Inventory ID 242, Town of Caledon (also in Stewart and Dilse 2008:24; Scheinman 2009:7-37, BC-10)

Indirect impacts to this resource may occur as a result of encroachment on to this property.

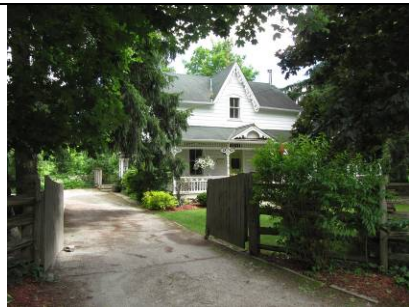
BHR 25	715 Bush Street	Residence	Nineteenth century Ontario Gothic residence; unknown foundation; wood siding; gable asphalt roof; 3-bay front façade with central entrance flanked by 2/2 sash windows; central gable dormer with 2/2 sash window; decorative vergeboard in dormer; front porch with decorative detailing and woodwork; excellent integrity/condition.	<i>Listed-High Significance:</i> Inventory ID 260, Town of Caledon (also in Stewart and Dilse 2008:24)

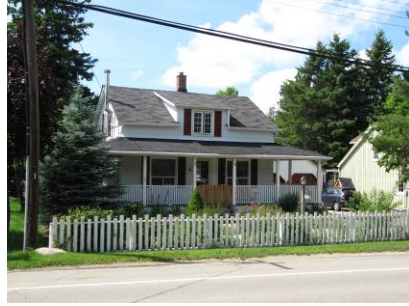
BHR 28	684 Bush Street	Residence	Early twentieth century vernacular residence; 1 ½ storeys; unknown foundation; vinyl siding; gable asphalt roof; centrally-located single internal brick chimney; 3-bay, symmetrical front façade with new windows; shed dormer above central entrance; porch wraps around the sides of house.	<i>Listed</i> : Inventory ID 263, Town of Caledon

Indirect impacts to this resource may occur as a result of encroachment on to this property.
BHR 29	628 Bush Street	Residence	Mid twentieth century vernacular residence; 1 ½ storeys; unknown foundation; wood clapboard siding; gambrel asphalt roof; enclosed front porch; modern casement windows; a gable roof drive shed or barn is located behind the house.	<i>Listed</i> : Inventory ID 265, Town of Caledon

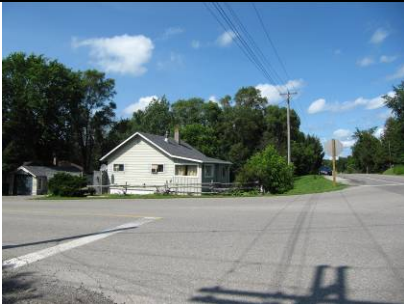
Feature	Location	Feature Type	Description/Comment*	Recognition/Reference(s)	Photo	Potential Impact
BHR 30	Northeast corner of Shaws Creek Road and Bush Street	Residence	Mid twentieth century vernacular residence; 1 storey; unknown foundation; vinyl siding; enclosed porch clad in wood board and batten siding; gable asphalt roof; single internal concrete block chimney; modern windows; the structure is located close to the intersection at Bush Street and Shaw Creek Road.	Identified during the field review

Indirect impacts to this resource may occur as a result of encroachment on to this property and its position at a corner of an intersection.
BHR 31	17217 Old Main Street	Residence	Mid twentieth century vernacular residence; 1 ½ storeys; unknown foundation; wooden board and batten siding on lower floor and wood shingles on upper floor; gable asphalt roof with shed roof over enclosed porch on front elevation; 2/2 windows on lower floor; skylights have been incorporated into the roof.	<i>Listed:</i> Inventory ID 249, Town of Caledon

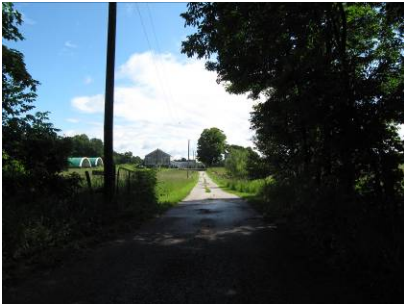
CHL 1	15663 Mississauga Road	Farm complex	This landscape consists of a 1 ½ storey Ontario Gothic farmhouse, a gable roof barn, and modern agricultural buildings. The residence, known as the David McDonald property and dating to ca. 1877, is a frame house with porch and central dormer with suicide door located on front elevation; rectangular property delineated by young tree lines (maples) and post & wire fence lines; long straight drive to the house; surrounding topography consists of low hills, fields. This landscape may be	<i>Listed:</i> Inventory ID 1517, Town of Caledon (also in Scheinman 2006: A-5, #11)

No impacts are expected to occur given the set back of the farmstead from the road.

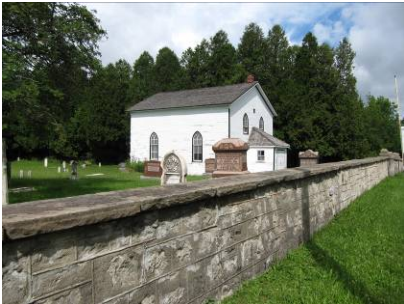
CHL 2	15962 Mississauga Road	Church and Cemetery	This landscape consists of the Melville Church and Cemetery; originally known as “Melville White Church” and which dates to 1837. The church is a heavy timber frame building with gable roof and a centrally placed internal chimney. The building was recently restored. Other cultural landscape features include: stone wall created in 1902 along ROW; cemetery markers arranged in parallel, mostly east-west lines; mix of mature trees along the north, south, and west boundaries of rectangular property; flat topography; and location in historic community of Rockside. This landscape may be described as a designed and evolved cultural heritage landscape.	<i>Designated:</i> Inventory ID 1518, Town of Caledon (also in Stewart and Dilse 2008: 42; Scheinman 2006:A-5, #13)

The cemetery, church structure and stone wall are located in close proximity to the road alignment and as such, they may be subject to direct impacts as a result of encroachment.

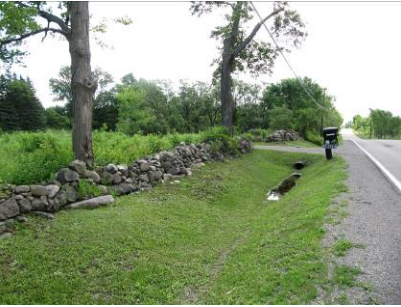
CHL 4	in front and across from 16110 Mississauga Road	Stone wall remnants	This landscape consists of remnant stone walls on either side of the ROW. Some portions remain more intact than others, while other parts are failing due to age, lack of maintenance, and removal of stones. These walls may continue further in either direction but their precise location and extent were difficult to determine due to vegetation overgrowth. This landscape may be described as a designed cultural heritage landscape.	Identified during field review

The remnant stone walls are located in close proximity to the road alignment and as such, they may be subject to direct impacts as a result of encroachment.

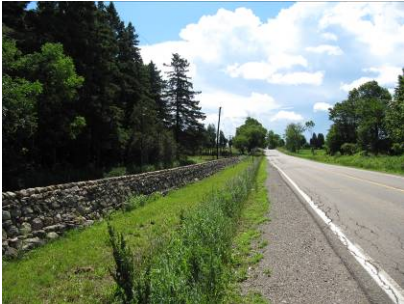
CHL 6	SE corner of Mississauga Road and Grange Side Road	Stone wall	This landscape consists of stone walls which are one of the last vestiges of the hamlet of Grange that was previously located at the corner of The Grange Side Road and Mississauga Road. These stone walls are in the process of being repaired by a hired contractor. They are constructed with limestone and described as granite dry laid walls (www.dswa.ca) and are possibly over 100 years old. This landscape can be described as a designed cultural heritage landscape.	<i>Designated:</i> Inventory ID 1646, Town of Caledon

The repaired stone walls are located in close proximity to the road alignment and may be subject to direct impacts as a result of encroachment.

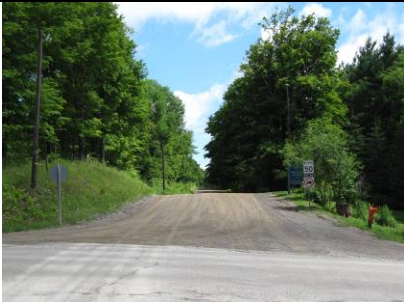
Feature	Location	Feature Type	Description/Comment*	Recognition/Reference(s)	Photo	Potential Impact
CHL 7	The Grange Side Road (east and west of Mississauga Road)	Roadscape	This transportation corridor follows the original road allowances as indicated on historic mapping and continues to contain elements evocative of its historic origin. This road features a narrow 2-lane ROW; is mostly gravel surface; lacks shoulders; and is bordered by undeveloped lands to either side. This landscape can be described as a designed cultural heritage landscape.	Identified during the field review

The Grange Side Road intersects Mississauga Road and may be subject to direct impacts.
CHL 8	NW corner of The Grange Side Road and Mississauga Road	Cemetery	This landscape consists of the Greenlaw Corners Pioneer Cemetery, and which marks the previous location of the Greenlaw Corners Congregational Church (or Union Church). Grave markers have been relocated to a single place at the north end of the property. The property is bounded by tree lines and roads and contains open green space. A flat area in front of the grave markers may mark the location of the former church. This landscape may be described as a designed and evolved cultural heritage landscape.	<i>Listed–High Significance:</i> Inventory ID 146, Town of Caledon (also in Scheinman 2006: 17-18)

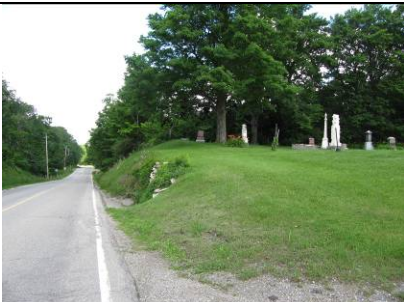
CHL 9	17025 Mississauga Road	Cemetery	This landscape consists of the Blair-Belfountain Community Cemetery. It is situated on elevated ground, on the crest of a hill where Mississauga Road starts to decline into the valley where Belfountain is located. The property is bounded by tree lines and Mississauga Road. A laneway leads into the cemetery with stone pillars to mark the entrance. A modern retaining wall accommodates road grading activities and a metal culvert is also extant. The cemetery	<i>Listed–High Significance:</i> Inventory ID 1523, Town of Caledon (also in Stewart and Dilse 2008; 42)

This site is located in close proximity to the road alignment and as such, it may be subject to direct impacts as a result of encroachment.

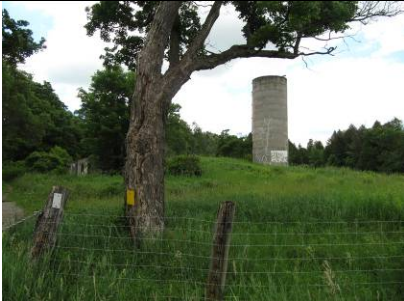
CHL 10	n/a	Remnant farm complex	This landscape consists of a silo and scattered concrete foundations. The property is bounded by post and wire fencing and tree lines. A centrally located driveway is still extant and vegetation is overgrown. This landscape can be described as an evolved cultural heritage landscape.	<i>Listed:</i> Inventory ID 259, Town of Caledon

The farm complex is set back from the road alignment. No direct or indirect impacts are expected.

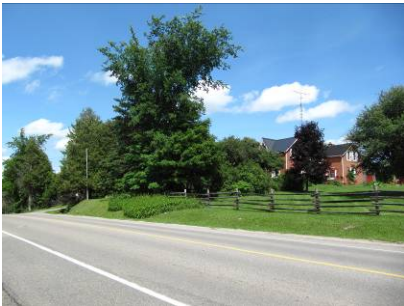
CHL 11	523 Bush Street	Farm complex	This landscape consists of a farmhouse, barns, and additional landscape features. The farmhouse is a 1 ½ storey brick Ontario Gothic structure with a rear 1 ½ storey accretion, both with gable roofs. A decorative vergeboard is located on the central dormer of the farmhouse. The two barns are well-maintained and feature gable roofs and stone foundations. The barns are set back from the house but clustered together and are elevated above the grade of Bush Street. A paved driveway leads from Bush Street and a dirt laneway	<i>Listed:</i> Inventory ID 266, Town of Caledon

The farm complex is set back from the road alignment. No direct or indirect impacts are expected.

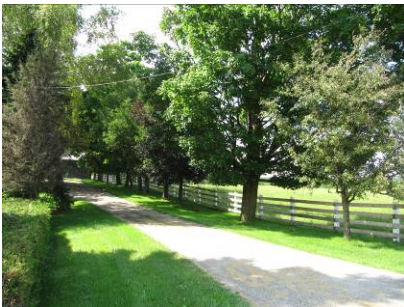
CHL 12	330 Bush Street ²	Farm complex	This landscape consists of a farmhouse, barn, and landscape features. The farmhouse is a 1 ½ storey structure with gable roof and features a modern shed dormer, vinyl siding, and an external chimney stack. The house likely dates to the nineteenth century but the exterior has been modified. The barn has a gable roof and stone foundation. The house is located near the ROW while the barn is set well back from the road. A long tree-lined gravel	Listed: Inventory ID 1557, Town of Caledon

The house and part of the mature tree line bounding the driveway is located in close proximity to the road alignment and as such, it may be subject to direct impacts as a result of encroachment.

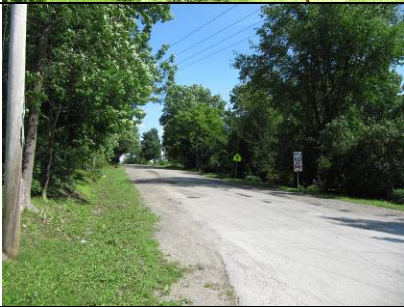
CHL 13	Shaw Creek Road (south of Bush Street)	Roadscape	This transportation corridor follows the original road allowances as indicated on historic mapping and contains elements evocative of its historic origin. It features a narrow two-lane ROW; mostly gravel surface; and lacks shoulders. Undeveloped lands are located to either side of the ROW. This landscape can be described as a designed cultural heritage landscape.	Identified during the field review

The Shaw Creek Road intersects Bush Street and may be subject to direct impacts.

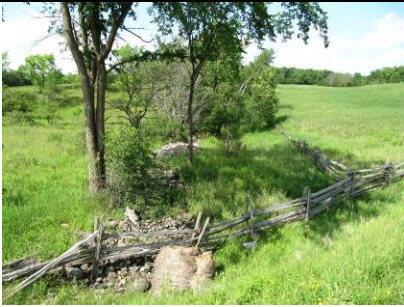
CHL 14	East of Winston Churchill Blvd, North of Bush Street	Stone walls	This landscape consists of stone walls that divide fields and which serve to mark boundaries between fields and the road. These are historic and appear to have been left to decay. This landscape can be described as a designed cultural heritage landscape.	Identified during the field review

Portions of the remnant stone walls are located in close proximity to the road alignment and as such, they may be subject to direct impacts as a result of encroachment.

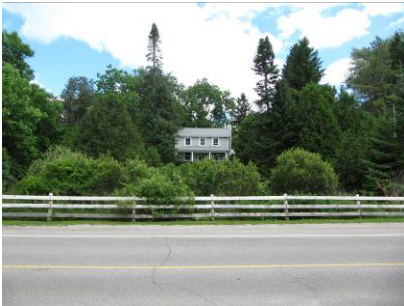
CHL 16	699 Bush Street	Residence; former farm complex	This landscape consists of a farmhouse, outbuilding, and landscape features. The farmhouse, also known as the Drury Residence and dating to ca.1860 is a 2-storey 3-bay structure with symmetrical facade, central entrance and gable roof; 2/2 sash windows; wood clapboard exterior; exterior chimney stack on west elevation; and a porch on front elevation covering the entire façade width. The house is located on elevated land, is set back from the ROW, and is surrounded by mature trees. Shrubbery and wooden fencing is located along the ROW. Aerial photographs show outbuildings behind the house. This is an evolved cultural heritage landscape	<i>Listed–High Significance:</i> Inventory ID 262, Town of Caledon (also in Stewart and Dilse 2008:24; Scheinman 2009: 7-38, BC-7)

The farm complex is set back from the road alignment. No direct or indirect impacts are expected.

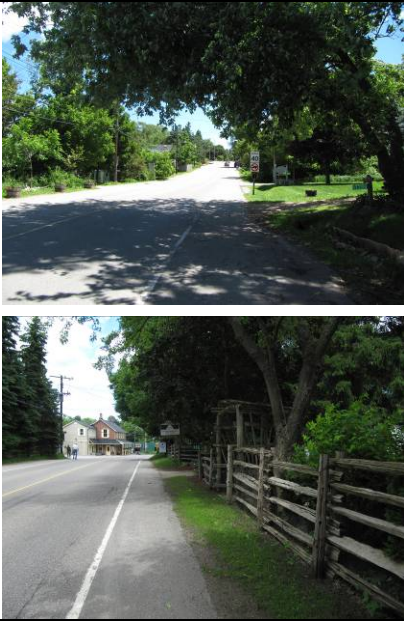
Direct and indirect impacts to the Belfountain historic core streetscape are expected as a result of encroachment and construction activities.

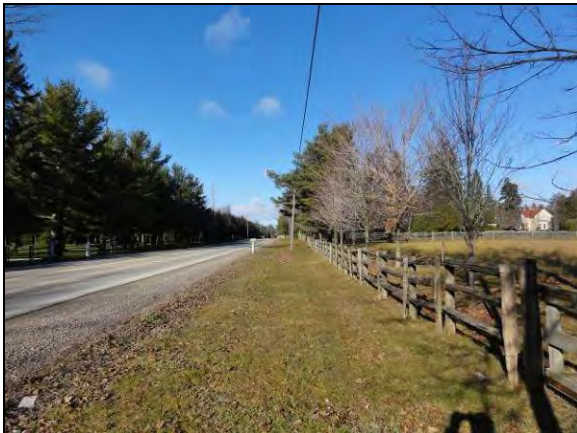
Plate 1: Wide gravel and grassy shoulders of Winston Churchill, looking north, 15547 Winston Churchill Blvd.

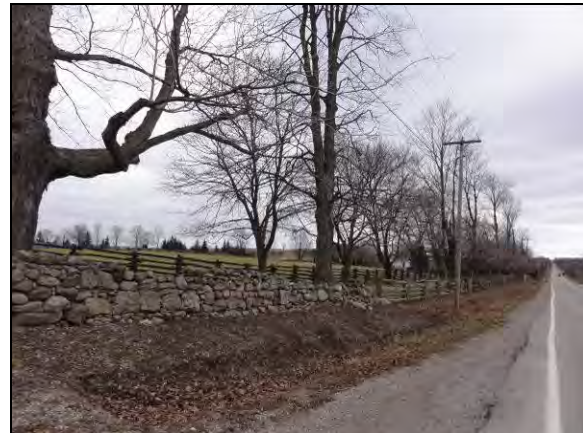
Plate 2: Typical example of stone wall, cedar rail fence, and tree lined roadway, looking south, 16245 Winston Churchill Blvd.

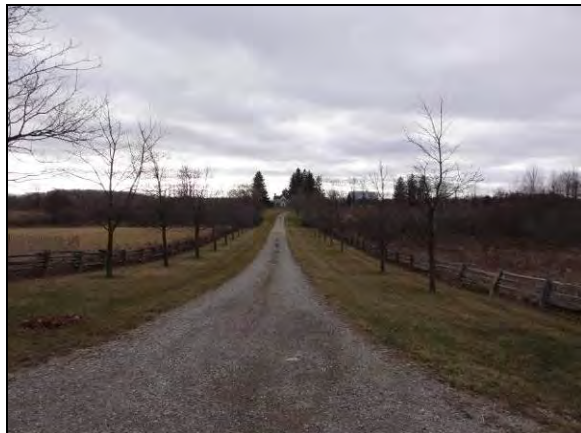
Plate 3: Example of a farm complex set well back from the road, looking west, 5148 Winston Churchill Blvd.

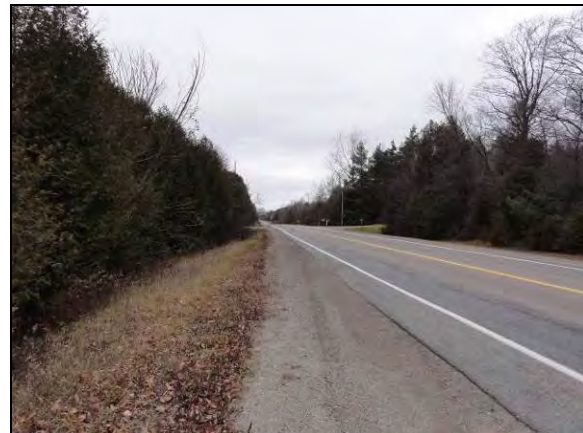
Plate 4: View of wooded area along Winston Churchill Blvd., south of Sideroad 10.

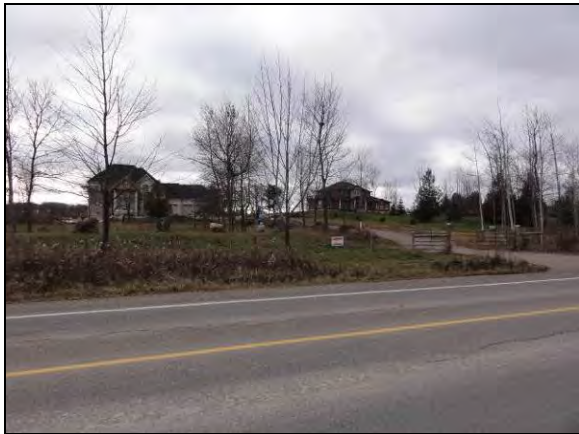
Plate 5: Example of modern residential properties, west side of Winston Churchill Blvd.

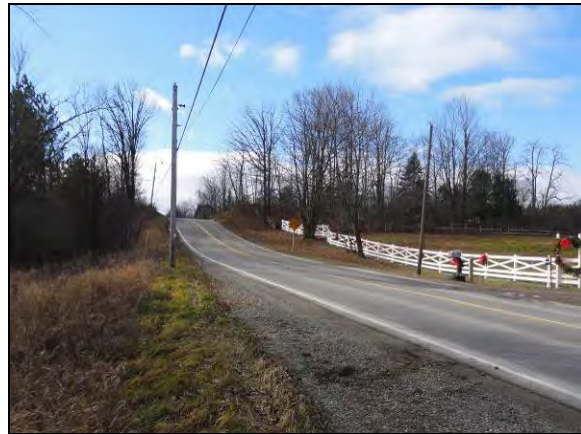
Plate 6: Modern fence and fields adjacent to Olde Base Line Rd looking west, 340 Olde Base Line Rd.

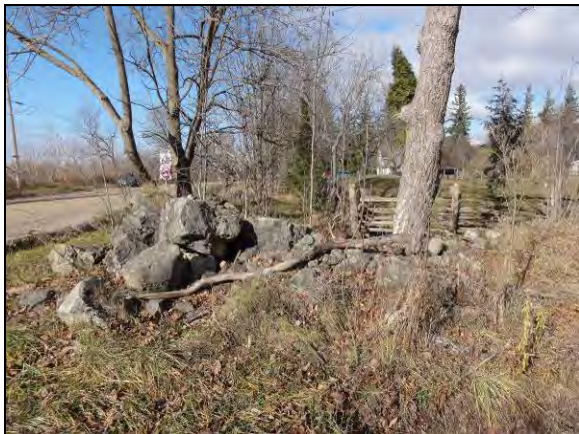
Plate 7: Example of boulder fence and cedar rail fence, corner of Shaws Creek Rd and Olde Base Line Rd.

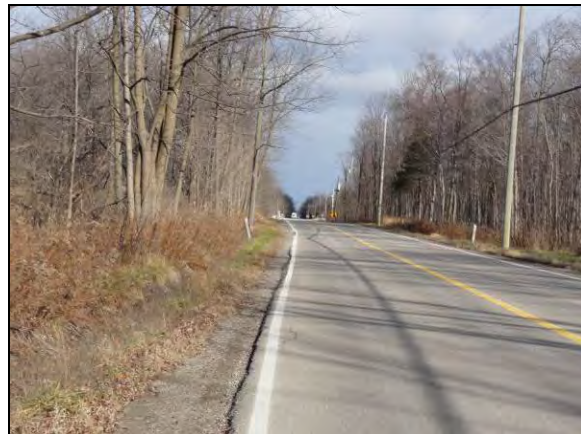
Plate 8: Minimal shoulders and wooded landscape along Olde Base Line Road, looking towards Mississauga Rd.

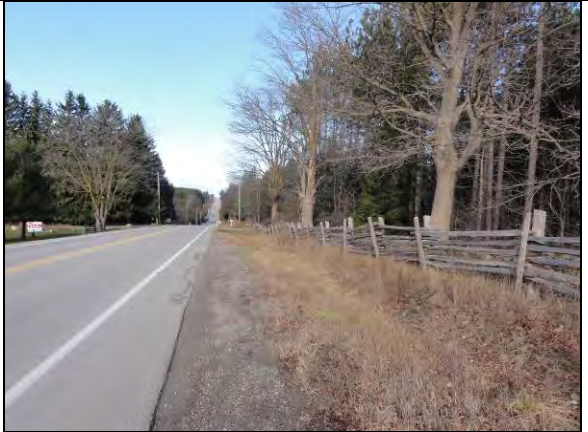
Feature	Inventory Description	Photograph(s)
CHL 1	<p>Location: 17401 Winston Churchill Blvd., Caledon Feature Type: Farm complex Recognition: Listed on Caledon's Built Heritage Inventory.</p> <p>Historical:</p> <ul style="list-style-type: none"> - On nineteenth-century historic mapping, this property was owned by a 'non-resident'. <p>Design:</p> <ul style="list-style-type: none"> - The farmstead on this property is set well back from the road and is not visible from the ROW. - This is an example of a designed cultural heritage landscape, and consists of planned woodlots, open fields separated by stone walls and cedar fences, mature tree lines, and a long entrance driveway. <p>Context:</p> <ul style="list-style-type: none"> - Contributes to the agricultural character of the area through retention of fields, woodlots, tree lines, wooden fences and stone fences. <p>Character-defining attributes that are located within the study corridor and adjacent to Winston Churchill Blvd. include:</p> <ul style="list-style-type: none"> - Cedar rail fence located around perimeter of the property - Low stone rubble wall behind portions of cedar rail fence - Coniferous tree line/wind break located at southwest corner of property

<p>Cedar rail fencing along ROW, looking north.</p>

3. CHL 1, CHL 5, and landscape features identified within CHL 7 are expected to be impacted through the removal/displacement of culturally significant fencing and/or heritage stone walls as a result of proposed grading limits and property acquisitions/easements. The following recommendations should be considered, in order of preference:

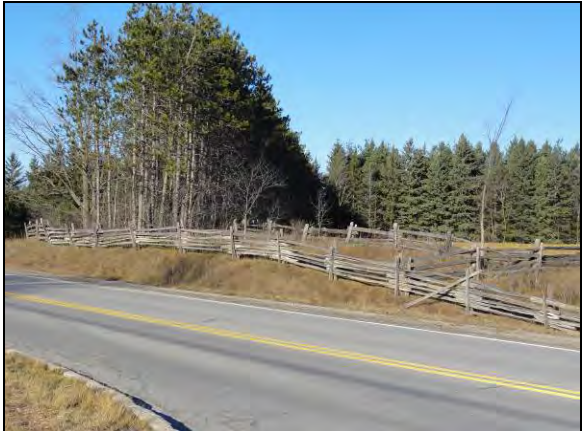
<p>Cedar rail fences along Bush St., looking north.</p>

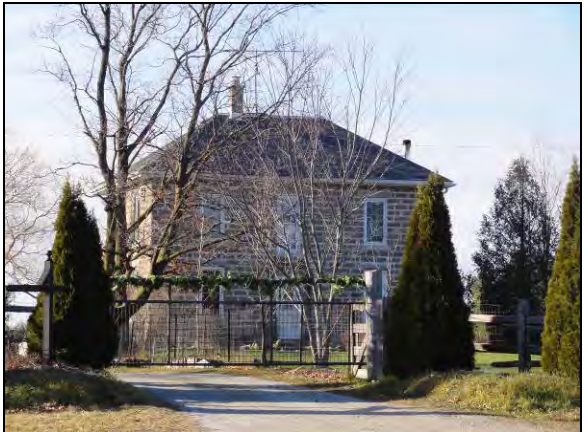
CHL 2	<p>Location: 5364 Winston Churchill Blvd., Erin Feature Type: Farm complex Recognition: Listed on Erin's Heritage Inventory</p> <p>Historical:</p> <ul style="list-style-type: none"> - On nineteenth-century historic mapping, this property was owned/occupied by A. McLaren. <p>Design:</p> <ul style="list-style-type: none"> - This two-storey, concrete block dwelling with hipped roof features an internally-bracketed chimney, modern multi-paned windows and rectangular footprint. - The house faces east and is centrally located with outbuildings situated out behind and to the south.

<p>East elevation (front façade) of concrete block house.</p>
