Appendix C

**Mississauga Road / Old Main Street
and Bush Street**

**Stage 1 Archaeological Assessment
(Background Research and Property Inspection)**

**Mississauga Road Improvements from Olde Base Line Road to Bush Street and
Bush Street From Mississauga Road to Winston Churchill Boulevard
Class Environmental Assessment,
Regional Municipality of Peel, Ontario**

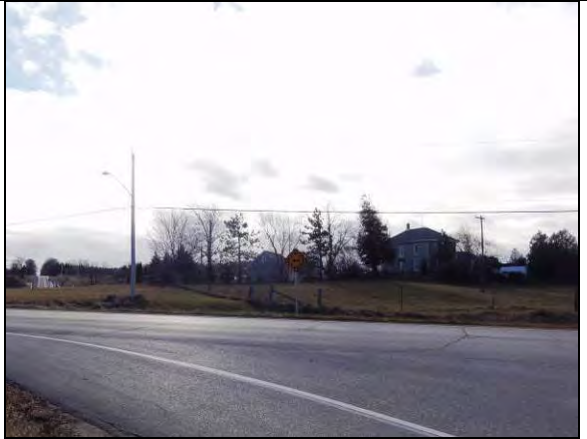
<p>Looking south from Bush Street towards property.</p>
CHL 3	<p>Location: 5314 Winston Churchill Blvd., Erin Feature Type: Farm complex Recognition: Listed on Erin's Heritage Inventory</p> <p>Historical:</p> <ul style="list-style-type: none"> - On nineteenth-century historic mapping, this property was owned/occupied by I. Longstreet. <p>Design:</p> <ul style="list-style-type: none"> - The farmstead on this property is set well back from the road and is screened by a largely coniferous woodlot. A mature line of deciduous trees along the west side of Winston Churchill Blvd was noted, along with two stone posts/piers at the entrance drive. <p>Context:</p> <ul style="list-style-type: none"> - Contributes to the agricultural character of the area through retention of the farmstead, long drive, mature trees, and entrance drive posts. <p>Character-defining attributes that are located within the study corridor and adjacent to Winston Churchill Blvd. include:</p> <ul style="list-style-type: none"> - Remnant deciduous tree line - Stone pillars at entrance drive

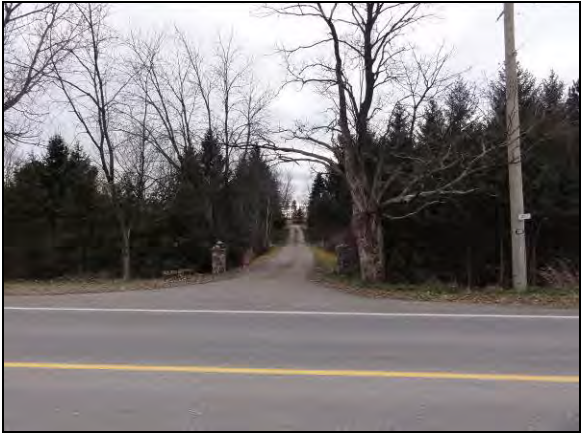
<p>Looking west down the long entrance drive to 5314 Winston Churchill Blvd.</p>

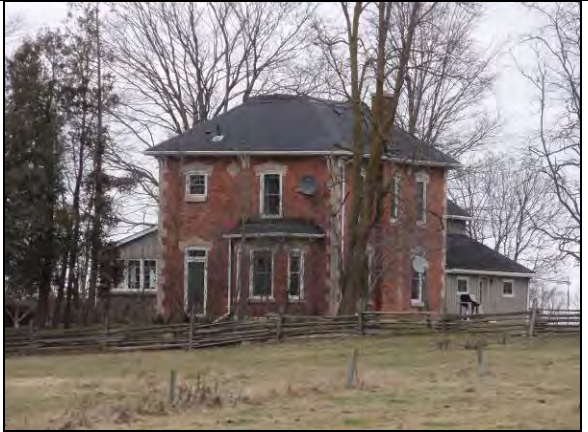
Feature	Inventory Description	Photograph(s)
CHL 4	<p>Location: 17049 Winston Churchill Blvd., Caledon Feature Type: Farm complex Recognition: Listed on Caledon's Built Heritage Inventory. "Heatherlea Farm Market"</p> <p>Historical:</p> <ul style="list-style-type: none"> - On nineteenth-century historic mapping, this property was owned/occupied by J. Cook(?). This house appears on the 1877 map. <p>Design:</p> <ul style="list-style-type: none"> - The two storey brick dwelling with hipped roof, tall chimney stack, first storey bay window, asymmetrical front façade, tall narrow windows, and decorative buff brick quoining and window/door arched lintels is an example of the Italianate architectural style popular in the late nineteenth century. - A number of outbuildings of various construction periods are located on the property. <p>Context:</p> <ul style="list-style-type: none"> - Contributes to the agricultural character of the area through retention of the brick farmhouse, long entrance drive, fields and cedar fence lines, and outbuildings. <p>Character-defining attributes that are located within the study corridor and adjacent to Winston Churchill Blvd. include:</p> <ul style="list-style-type: none"> - Cedar rail fence located around field to south of building cluster

<p>Southwest elevation of the farmhouse.</p>

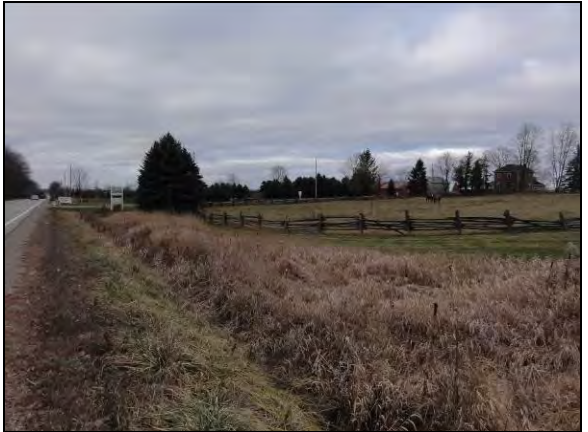
<p>View of subject property adjacent to the ROW.</p>

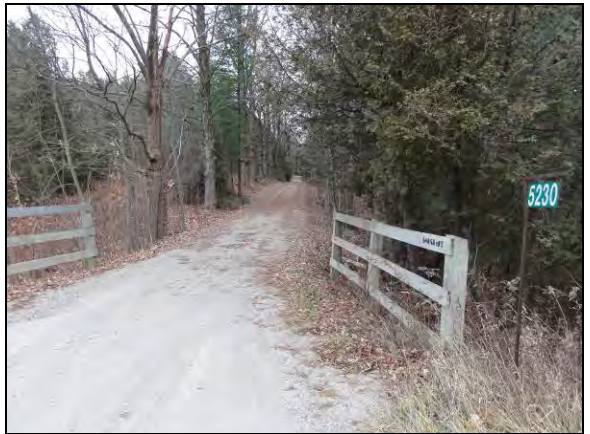
<p>Looking west down the long entrance drive to 5230 Winston Churchill Blvd.</p>

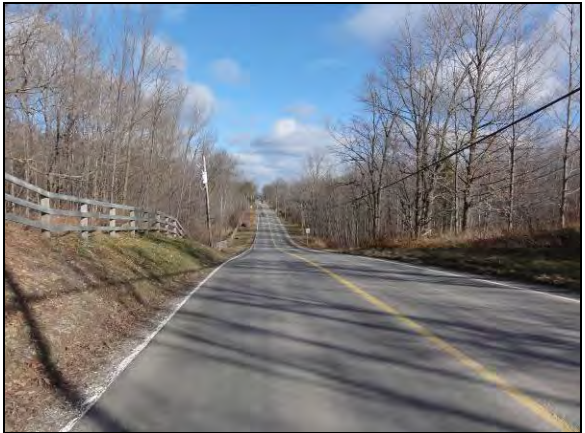
<p>Looking east from 551 Olde Base Line Rd.</p>

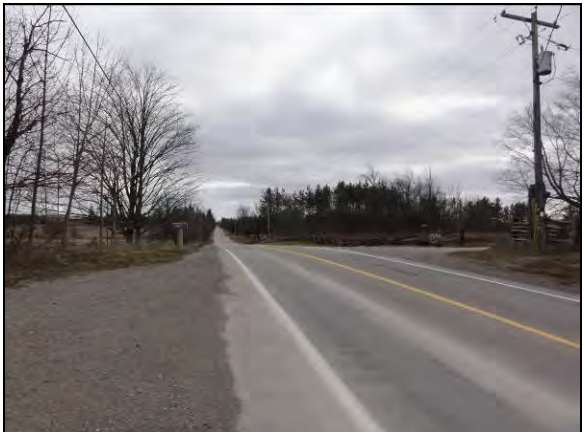
<p>Looking south from 5032 Winston Churchill Blvd.</p>

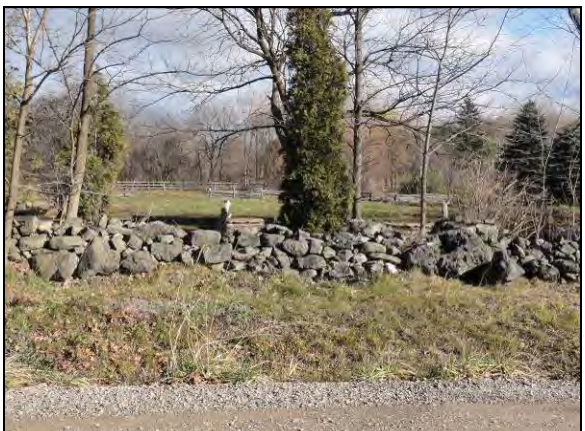
<p>Boulder fence on Olde Base Line Rd. at Shaws Creek Rd.</p>

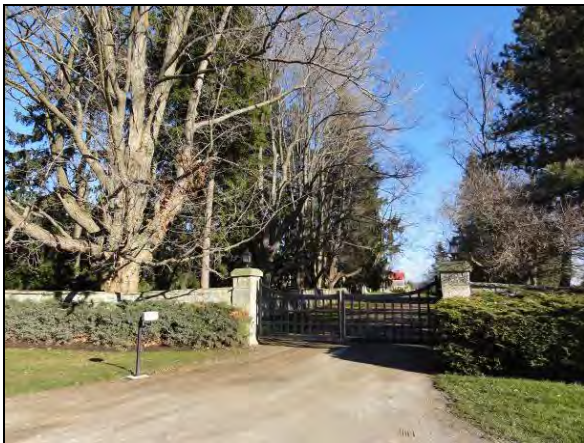
<p>View of mortared stone walls, pillars and gate to 15547 Winston Churchill Blvd., looking east.</p>

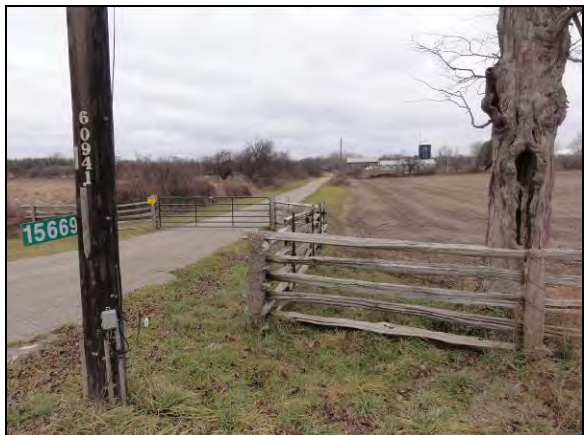
<p>View of cedar rail fence, driveway, and fields. associated with 15669 Winston Churchill Blvd.</p>

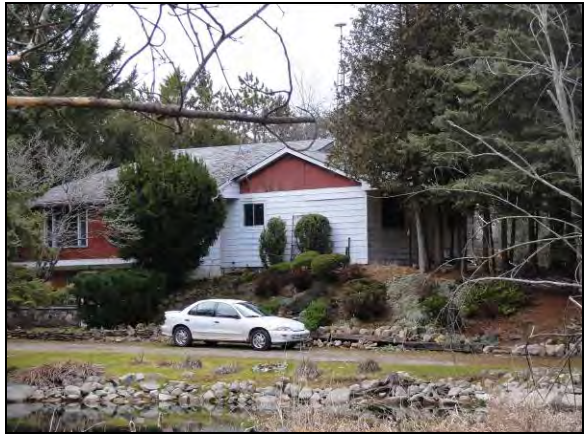
Feature	Inventory Description	Photograph(s)
BHR 1	<p>Location: 5268 Winston Churchill Blvd., Erin</p> <p>Feature Type: Dwelling</p> <p>Recognition: Identified during field review</p> <p>Historical:</p> <ul style="list-style-type: none"> - On nineteenth-century historic mapping, this property was owned/occupied by J. Davidson. <p>Design:</p> <ul style="list-style-type: none"> - This one storey frame house with hipped and gabled roof features synthetic siding, and varied fenestration. - The overall form, design and scale is typical of a mid-twentieth century cottage. <p>Context:</p> <ul style="list-style-type: none"> - Contributes to the rural character of the area through retention of the pond, gravel drive, and surrounding woodlot. <p>There are no character-defining elements associated with this property located within or immediately adjacent to the existing ROW.</p>

<p>Southeast elevation, view from ROW.</p>

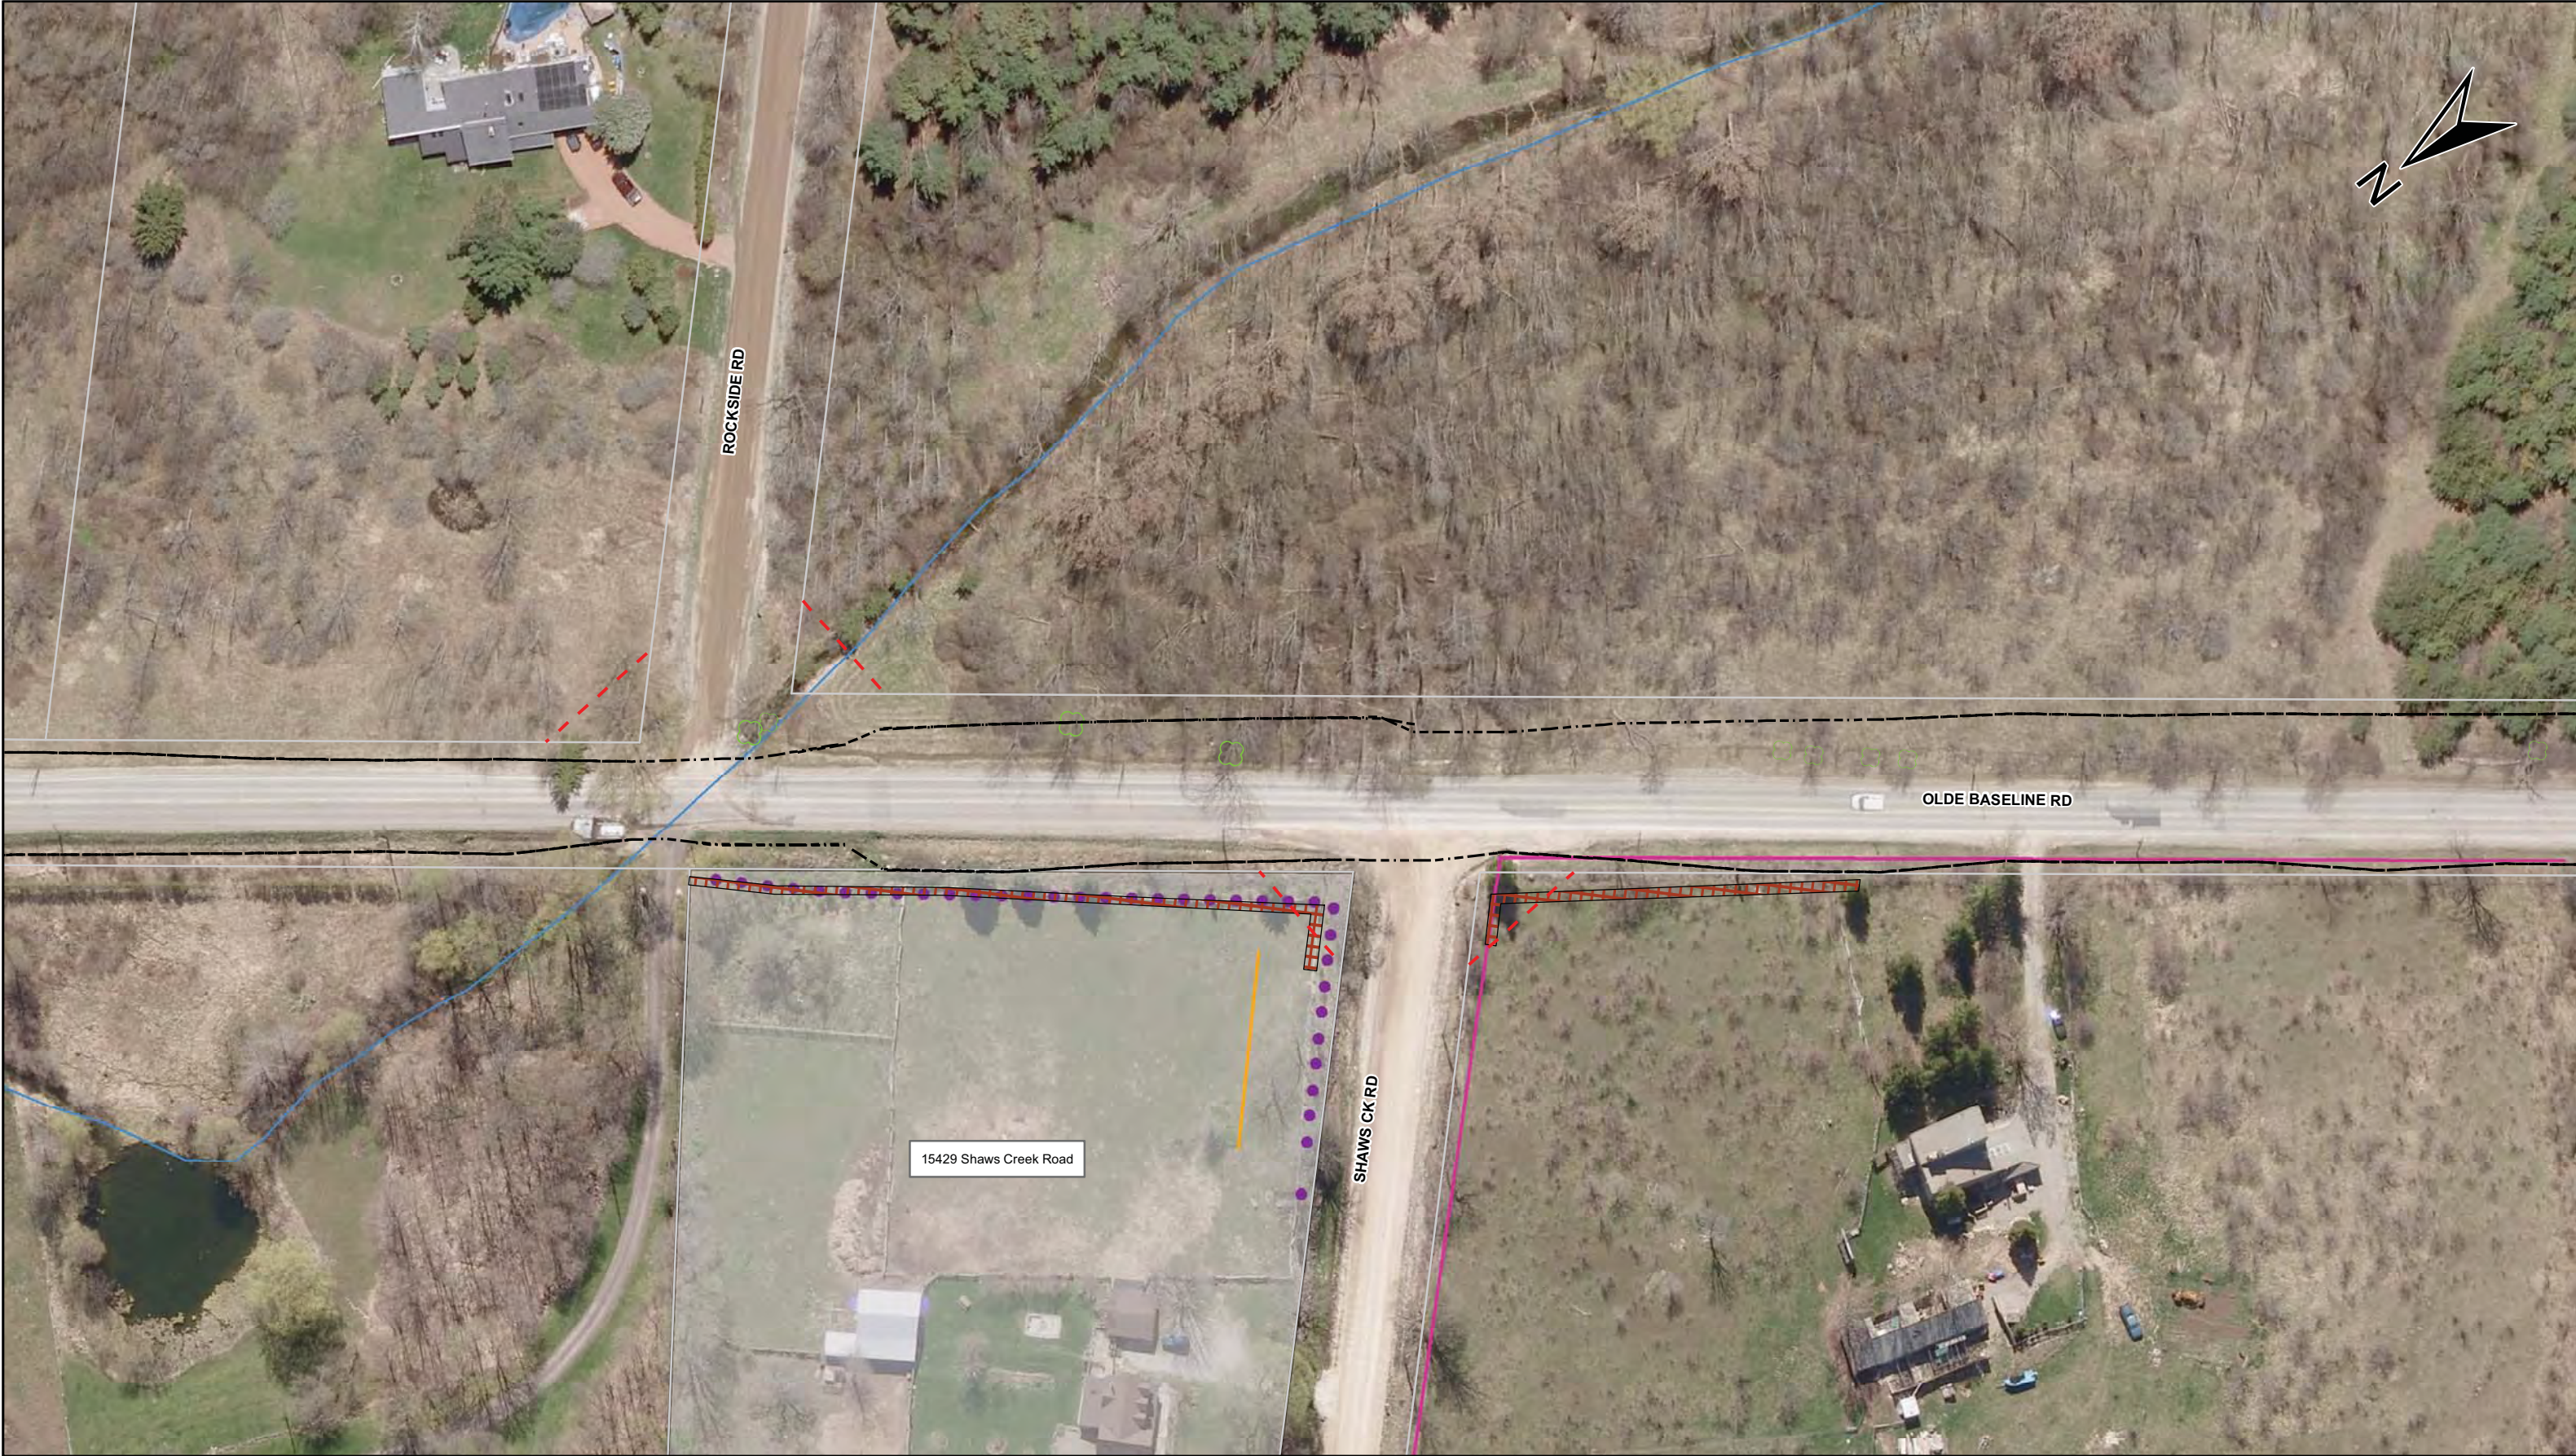
ASI PROJECT NO.: 11EA097/098
DATE: April 11, 2014
DRAWN BY: BW/JF
FILE: 11EA97_98_sheet20

CHL 7 Landscape Features			Proposed Layout		
Built Heritage Resources (BHR)	Rubble Stone Wall/Fence	Snake Rail Fence	Proposed Property Line	Tree	
Cultural Heritage Landscapes (CHL)	Treeline/Wind Break	Cedar Rail Fence	Proposed Grading Limit		
CHL 7 Boundary	Remnant Deciduous Tree Lined Road	Rubble Stone Fence with Cedar Shims	Culturally Significant Fence		
	Mortored Stone Wall	Cedar Split Rail on Rubble Stone	Heritage Stone Wall		
		Stone Pillars			
		Former Lime Kiln			
		Identified During Field Review			
		Listed on Heritage Inventory

3. CHL 1, CHL 5, and landscape features identified within CHL 7 are expected to be impacted through the removal/displacement of culturally significant fencing and/or heritage stone walls as a result of proposed grading limits and property acquisitions/easements. The following recommendations should be considered, in order of preference:
