Appendix O

Collision Diagrams

Project Name: Belfountain EA – Safety Review

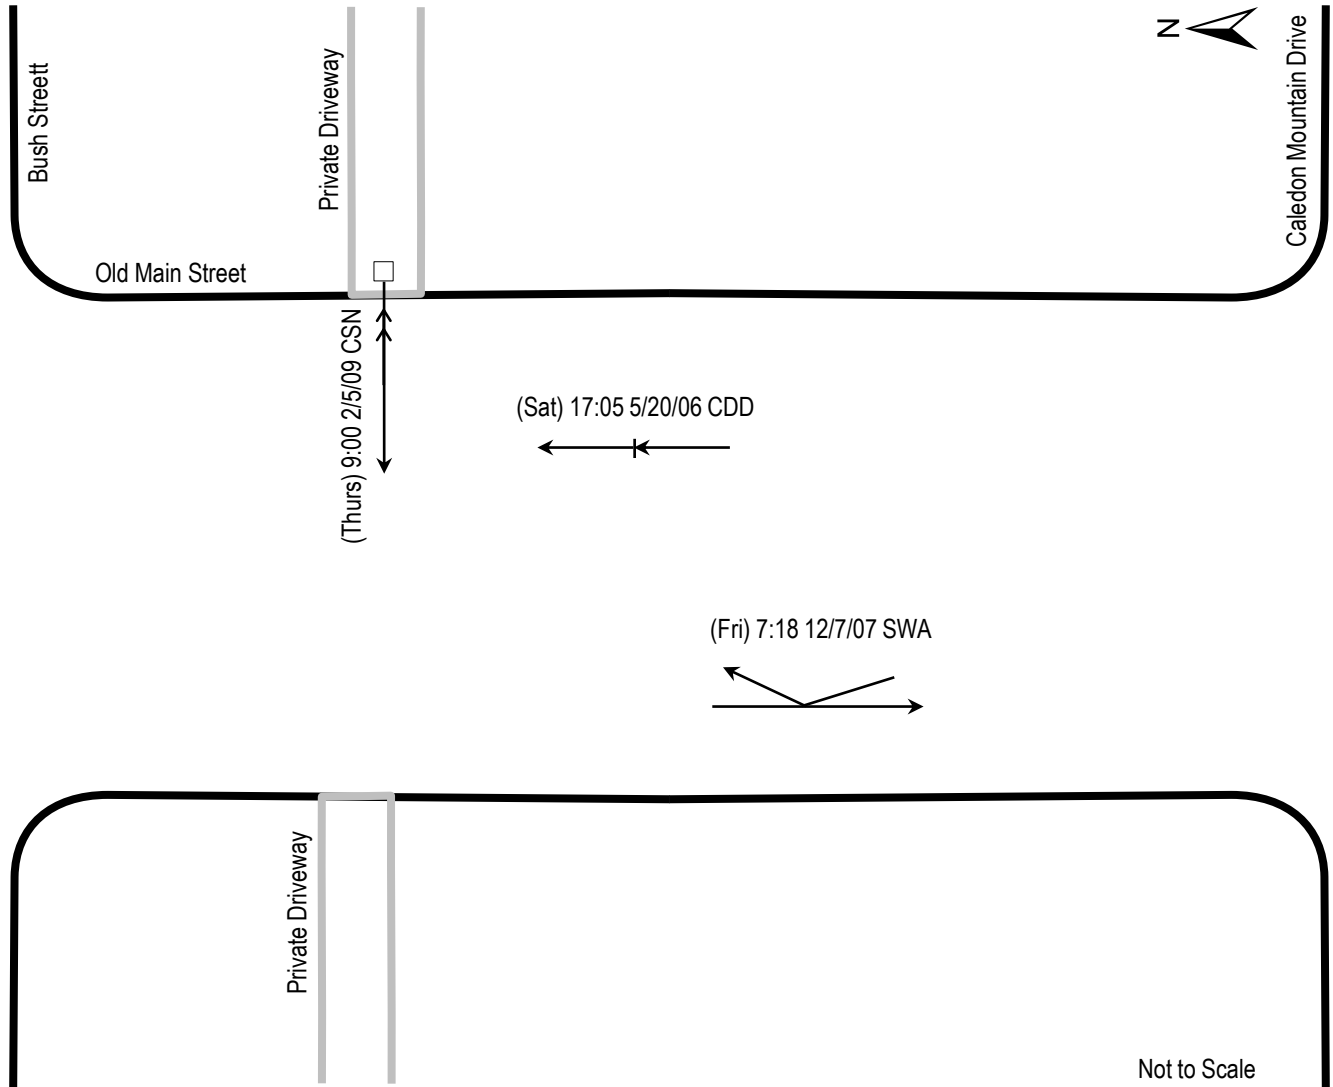
Exhibit #: A-6

Collision Diagram

Old Main Street between
Caledon Mountain Drive and Bush Street

Period From: January 1, 2006

Period To: December 31, 2010

Collision locations are approximate.
Number and configuration of private driveways is not representative of existing conditions.
* Collision occurred on curved section of roadway.
